Above the Flood: Elevating Your Floodprone House

FEMA 347/ May 2000

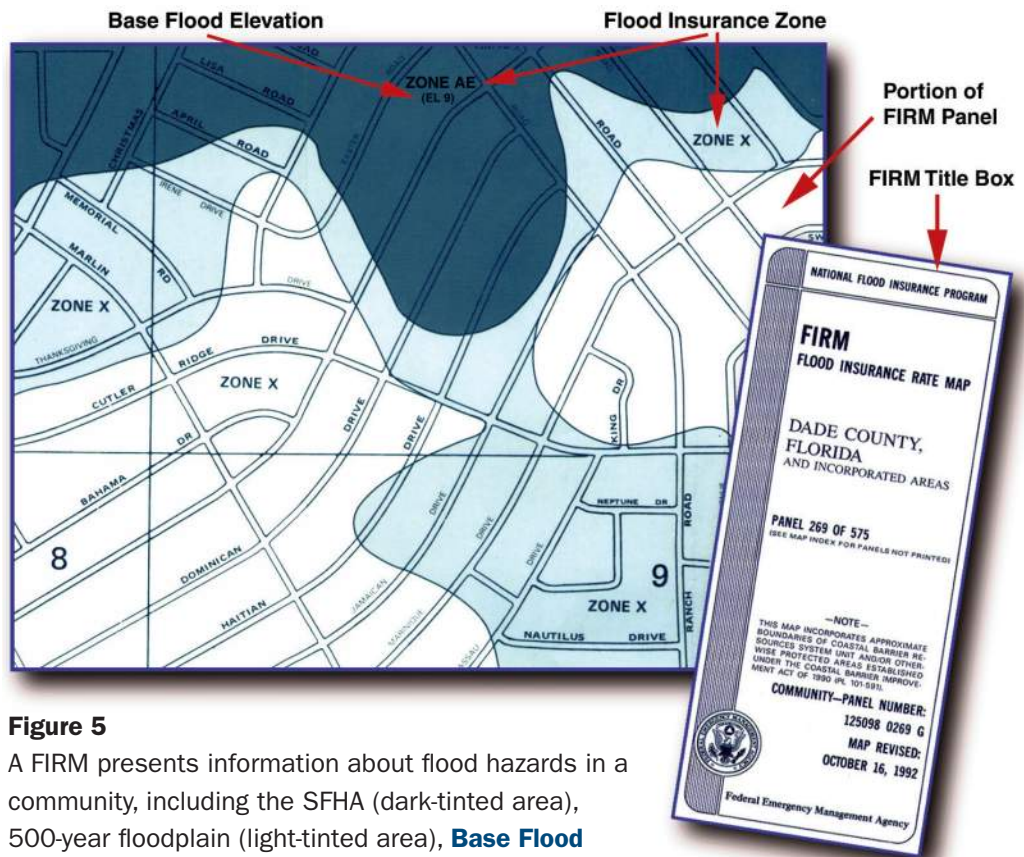
Figure 5
A FIRM presents information about flood hazards in a community, including the SFHA (dark-tinted area), 500-year floodplain (light-tinted area), **Base Flood Elevations**, (BFEs) (number in parentheses), and flood insurance zones (AE and X in this example).

Communities participate in the NFIP by enacting and enforcing floodplain management regulations to reduce future flood risks. At a minimum, these regulations govern construction in the **Special Flood Hazard Areas (SFHAs)** shown on Flood Insurance Rate Maps (FIRMs) issued by FEMA (Figure 5).

Note that the SFHA in the example in Figure 5 is designated Zone AE. This zone is only one of several applied to SFHAs under the NFIP, including V, VE, V1-V30, A, AE, A1-A30, AO, and AH. These zones indicate differences in the types and severity of flood hazards in SFHAs. For the purposes of this publication, it is sufficient to focus on the basic differences between the two main types of SFHA zones—V zones and A zones. The distinction is important because regulatory requirements associated with V zones and A zones differ significantly. As explained later in this chapter, these requirements affect the types of building elevation techniques that may be used under the NFIP.

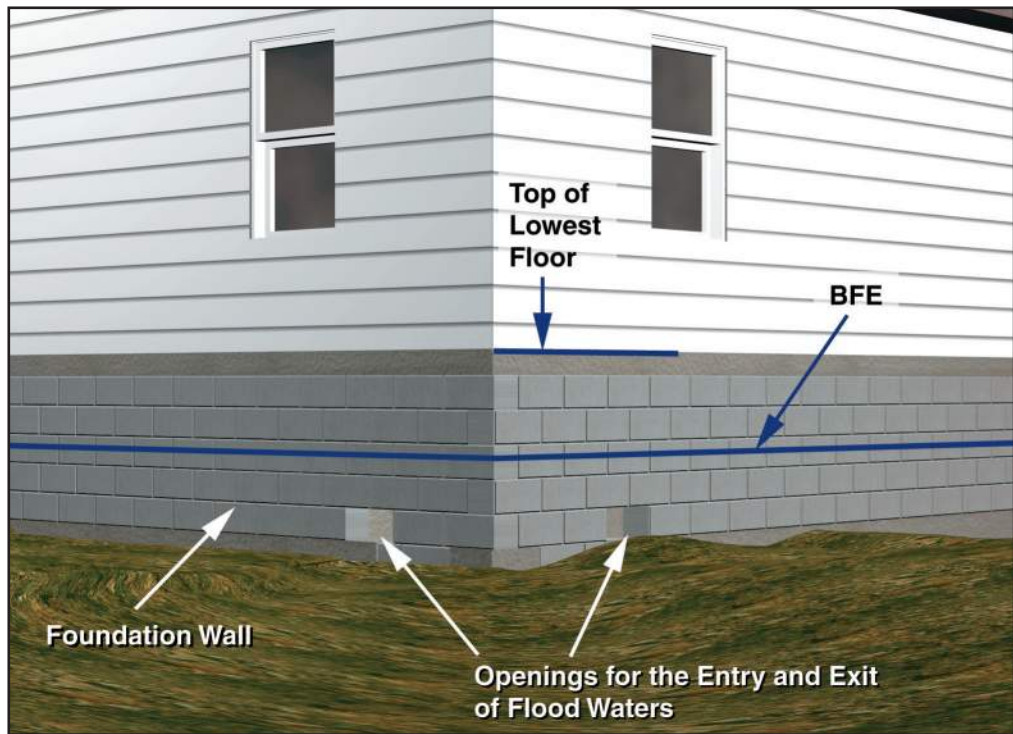
Figure 6
In a new, substantially improved, or substantially damaged building in an A zone, the elevation of the lowest floor must be at or above the BFE.

In A zones, where flood hazards are less severe, buildings may be elevated either on an open foundation or on continuous foundation walls below the BFE (Figure 6). Regardless of the type of foundation used, A-zone buildings must be elevated so that the **lowest floor** is at or above the BFE, as shown in Figure 6. If continuous walls are used below the BFE, they must be equipped with openings that allow flood waters to flow into and out of the area enclosed by the walls (Figure 6). Allowing the entry and exit of flood waters ensures that water pressures will be the same on both sides of the walls and reduces the likelihood that water pressure will cause the walls to fail.

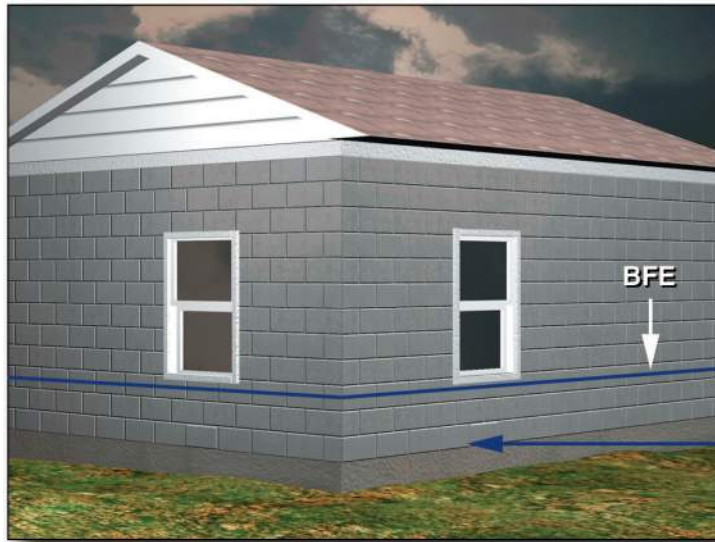
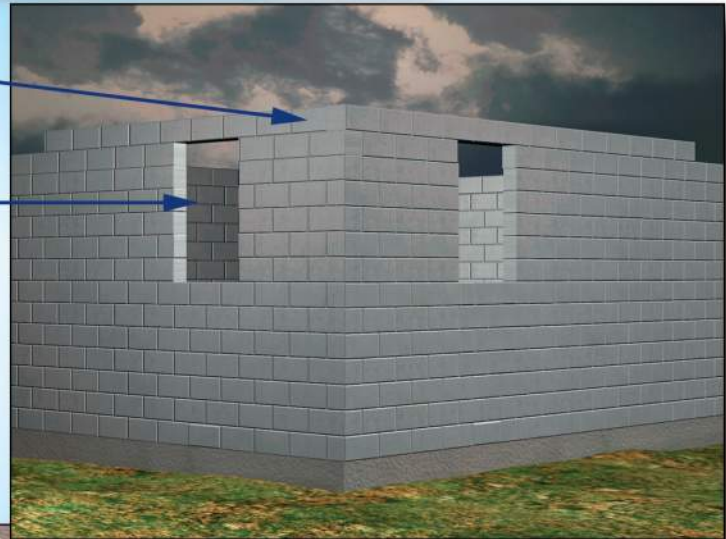
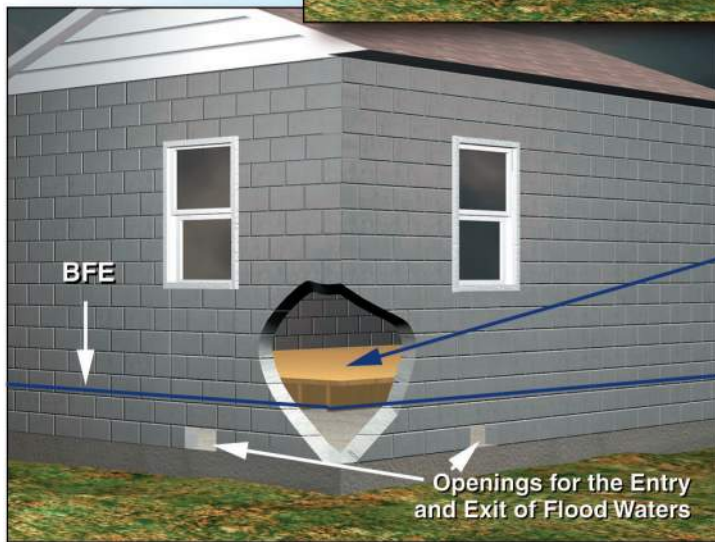
Figure 7
Technique 1 –
Extend the walls of the house upward and
raise the lowest floor.

House at the time
Hurricane Andrew
struck

Original Level
of the Lowest
Floor

Extended Walls

Raised Window
Opening

Substantially damaged house undergoing
repairs that will bring it into compliance
with Miami-Dade County floodplain
management requirements

New,
Raised Floor

House after
completion of repairs

1. Extend the walls of the house upward and raise the lowest floor (Figure 7).
2. Convert the existing lower area of the house to non-habitable space and build a new second story for living space (Figure 8).
3. Lift the entire house, with the floor slab attached, and build a new foundation to elevate the house (Figure 9).

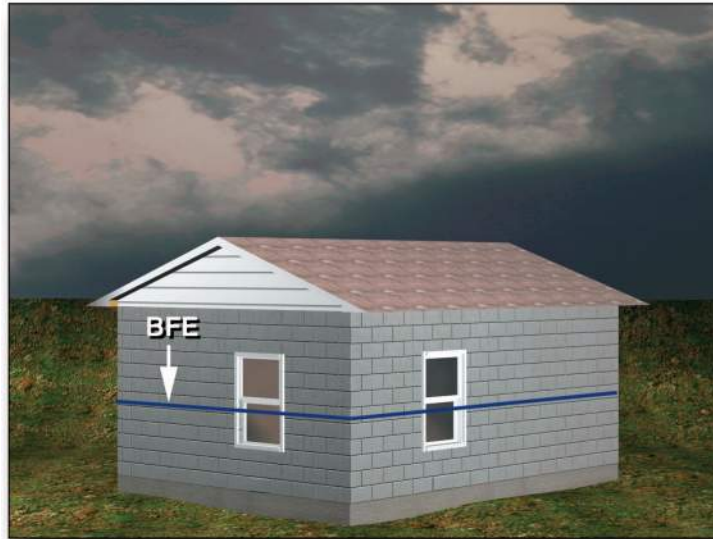
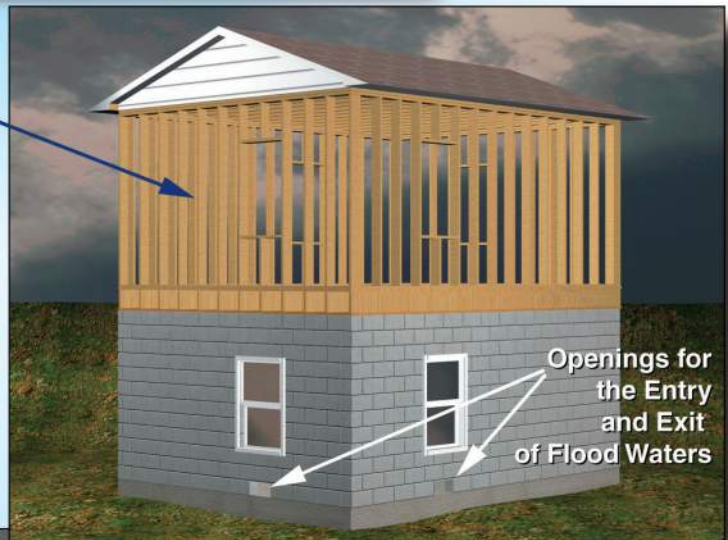
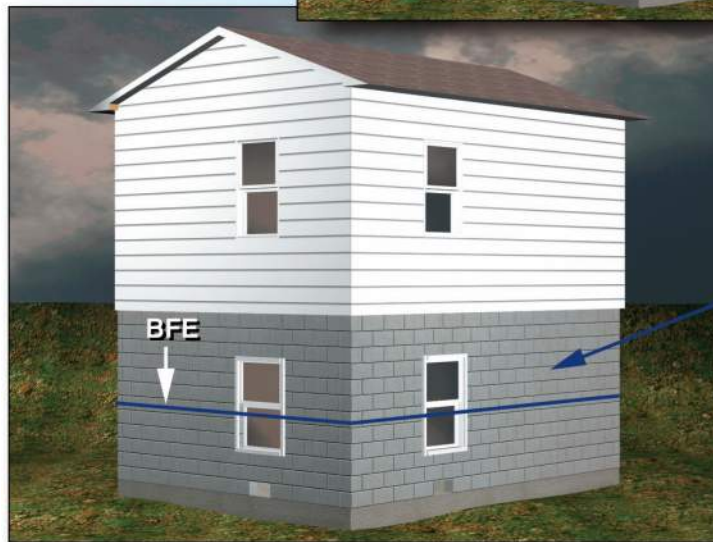
Technique 2 – Convert the existing lower area of the house to non-habitable space and build a new second story for living space.

House at the time Hurricane Andrew struck

New Second Story Above BFE

Substantially damaged house undergoing repairs that will bring it into compliance with Miami-Dade County floodplain management requirements

Openings for the Entry and Exit of Flood Waters

House after completion of repairs

Lower Area Converted to Non-Habitable Space for Storage, Parking, or Building Access

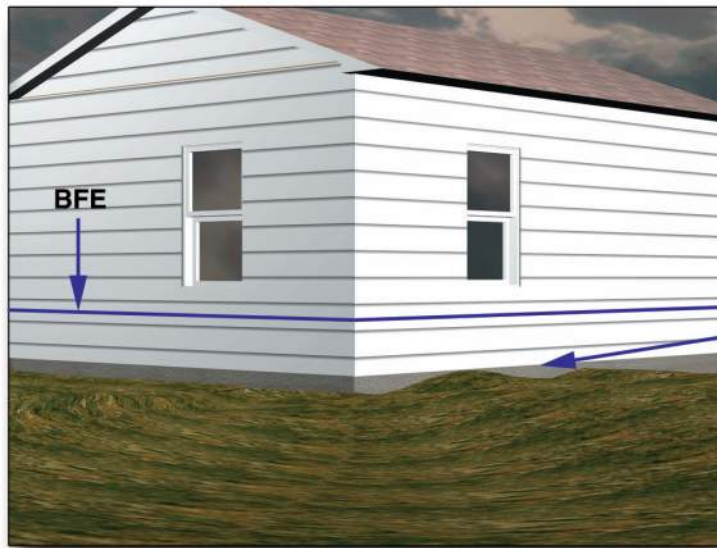
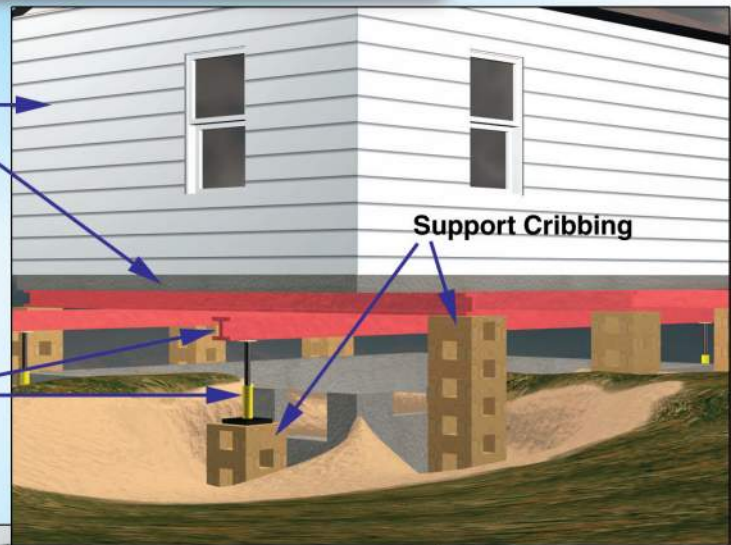
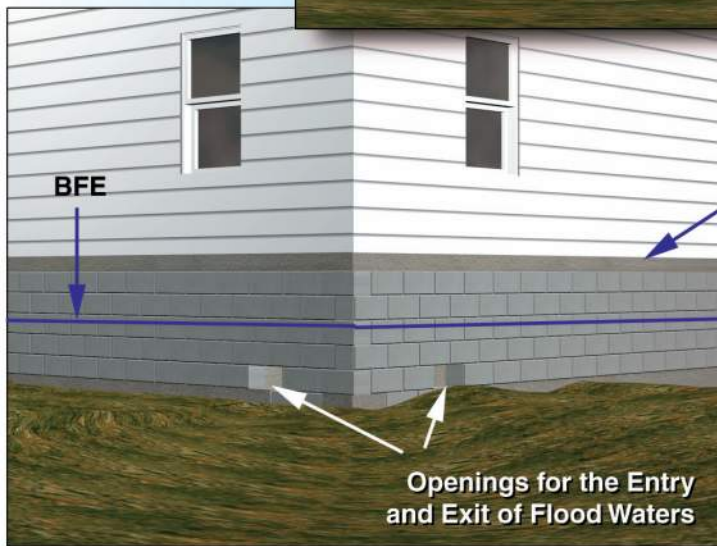
Figure 9
Technique 3 –
Lift the entire house,
with the floor slab
attached, and build
a new foundation to
elevate the house.

House at the time
Hurricane Andrew
struck

Original Level
of the Lowest
Floor

House and
Floor Slab
Lifted
Together

House Lifted
on Jacks and
I-Beams

Support Cribbing

New Level
of the Raised
Lowest Floor

House after
completion of
repairs

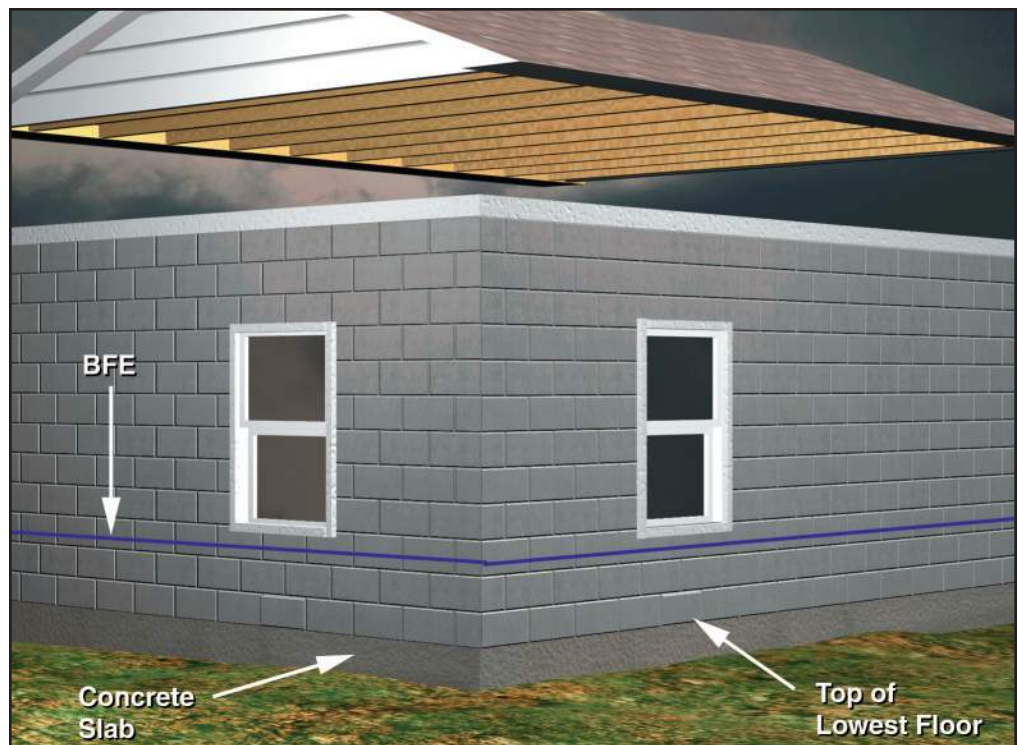
Figure 10
The first step in Technique 1 is removing the roof.

Technique 1 is appropriate for houses with concrete or masonry walls, but not for houses with other types of walls, such as those framed with wood studs, which would be more vulnerable to flood damage. This technique is usually appropriate when the depth of the base flood at the house is no more than 4 or 5 feet above grade. The elevation process begins with the temporary removal of the roof and roof framing, in a single piece if possible (Figure 10). This is commonly done with a crane. The roof is then stored on site so that it can be reinstalled later. The next step is to remove the windows and doors.

As in Technique 1, the repairs begin with the temporary removal of the roof and roof framing (Figure 10). After the roof is removed, construction of the new second story begins. First, a new wood-frame floor is built on top of the existing lower-story walls. The second-story walls are framed with metal or wood studs and set in place on the floor (Figure 15).

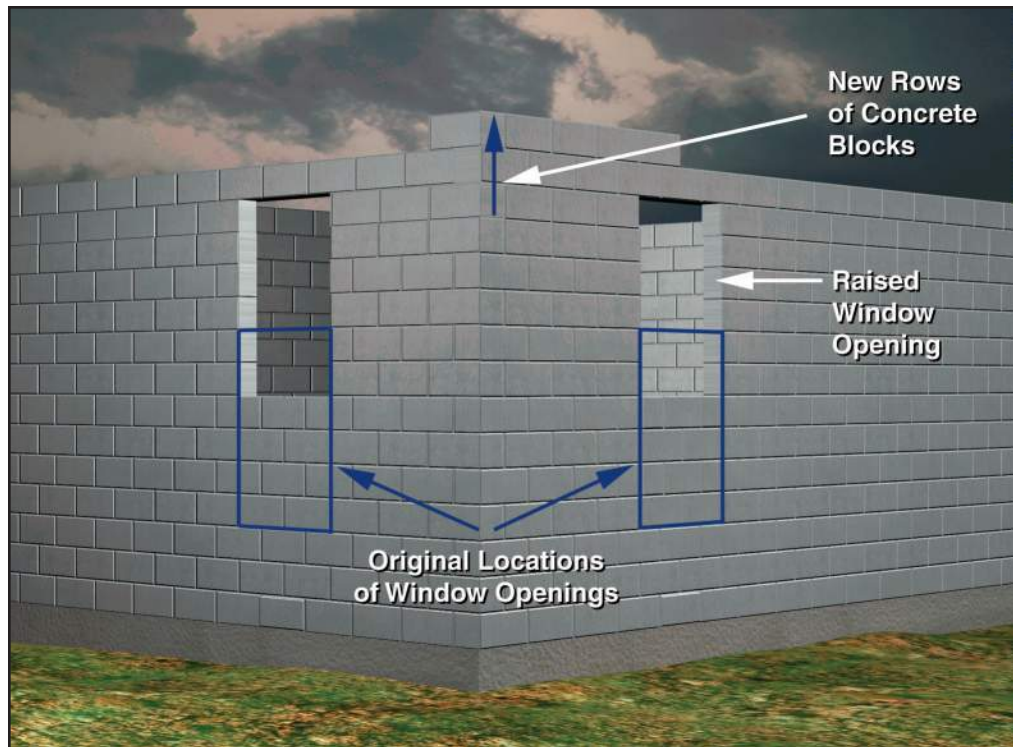
Figure 11

The tops of the walls and bottoms of the window openings are raised with concrete blocks.

After the roof, windows, and doors are removed, several courses of concrete block are added to the tops of the existing walls and to the bottoms of the window openings (Figure 11). A corresponding number of blocks are removed from the tops of the window openings so that the size of the windows will remain the same. In addition, although not shown in Figure 11, concrete bond beams are formed in place at the tops of the extended walls to provide structural reinforcement.

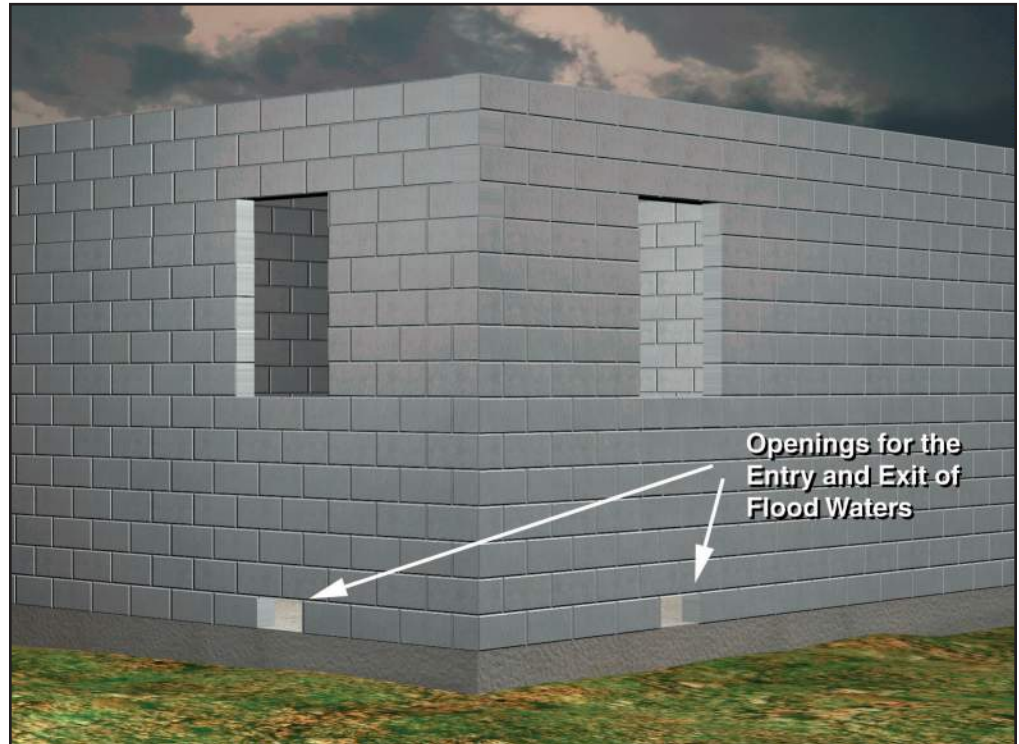
Figure 12
Openings are created in the walls near the ground.

Blocks are removed from the walls of the house at selected locations within 1 foot of the ground (Figure 12). The resulting openings will allow flood waters to flow into and out of the lower area of the house so that the water pressures on both sides of the walls will remain the same. The roof and windows are then replaced, and a new wood-frame floor is constructed above the flood level (Figure 13).

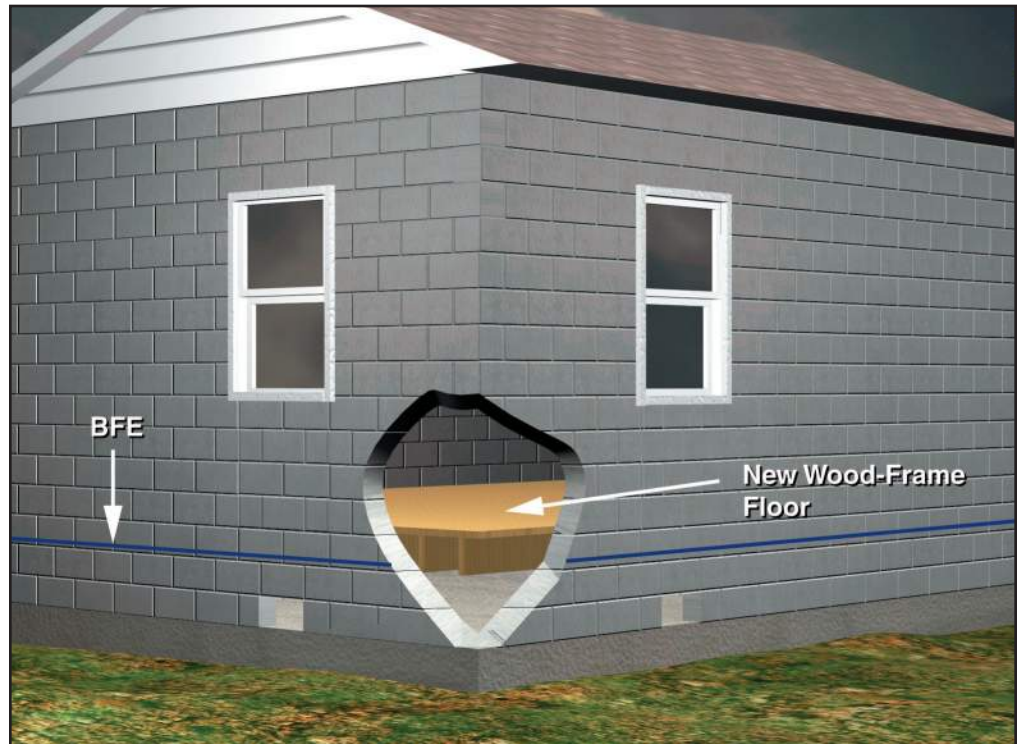
Figure 13
A new wood-frame lowest floor is constructed above the flood level, and the roof, windows, and doors are reinstalled.

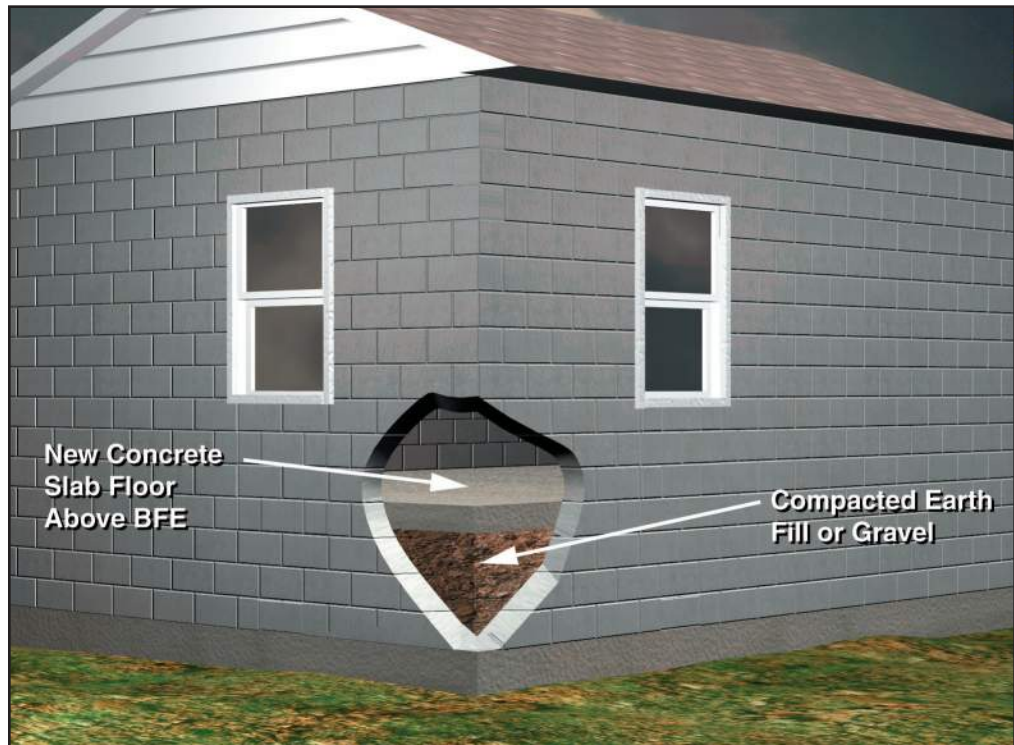
Figure 14
An alternative to building an elevated wood-frame floor is installing a new, elevated concrete slab floor on fill placed over the old slab.

A homeowner who chooses Technique 1 may decide to build a new concrete slab floor instead of a wood floor (Figure 14). When this option is chosen, compacted fill dirt or gravel is placed on top of the old slab and the new slab floor is poured on top. Because the area below the new floor is filled with dirt or gravel, wall openings are not required.

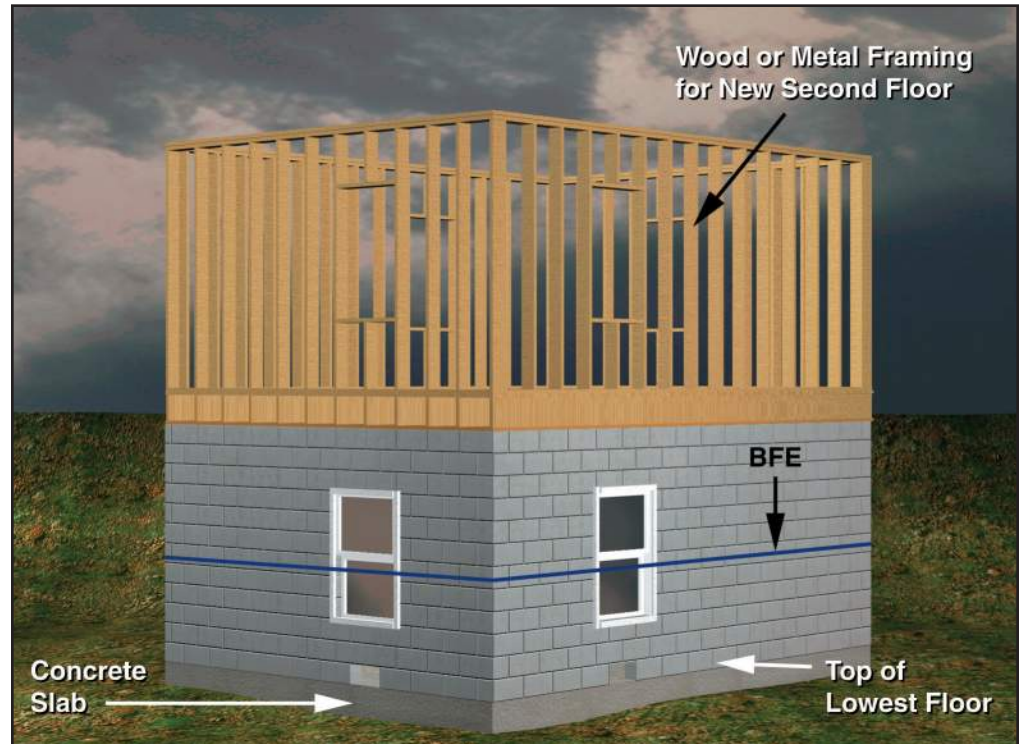
Figure 15
The new second-story floor and walls are built on top of the existing lower story.

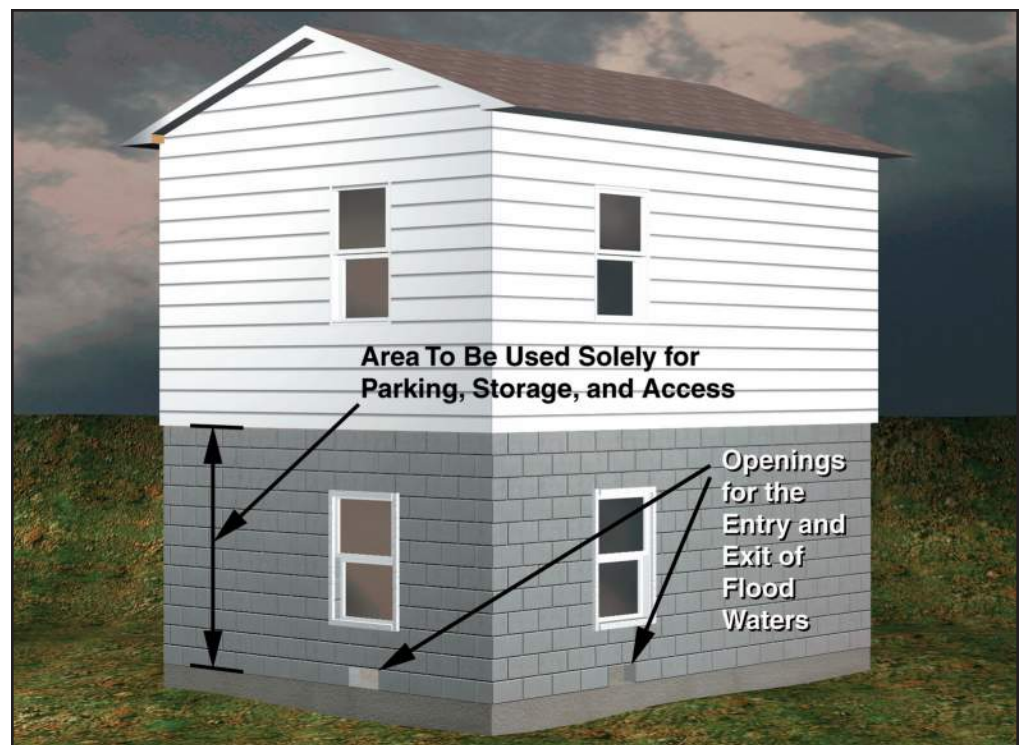
Figure 16
The new second-story walls are covered with siding or stucco.

Some homeowners prefer that the second story be constructed of masonry, but wood- or metal-framing is more common, primarily because it is lighter and less expensive. The roof is replaced, and blocks are removed from the walls to allow flood waters to enter and exit. Exterior sheathing is then added to the framed walls of the second story, the new windows are installed, and siding or stucco is applied to the sheathing (Figure 16).

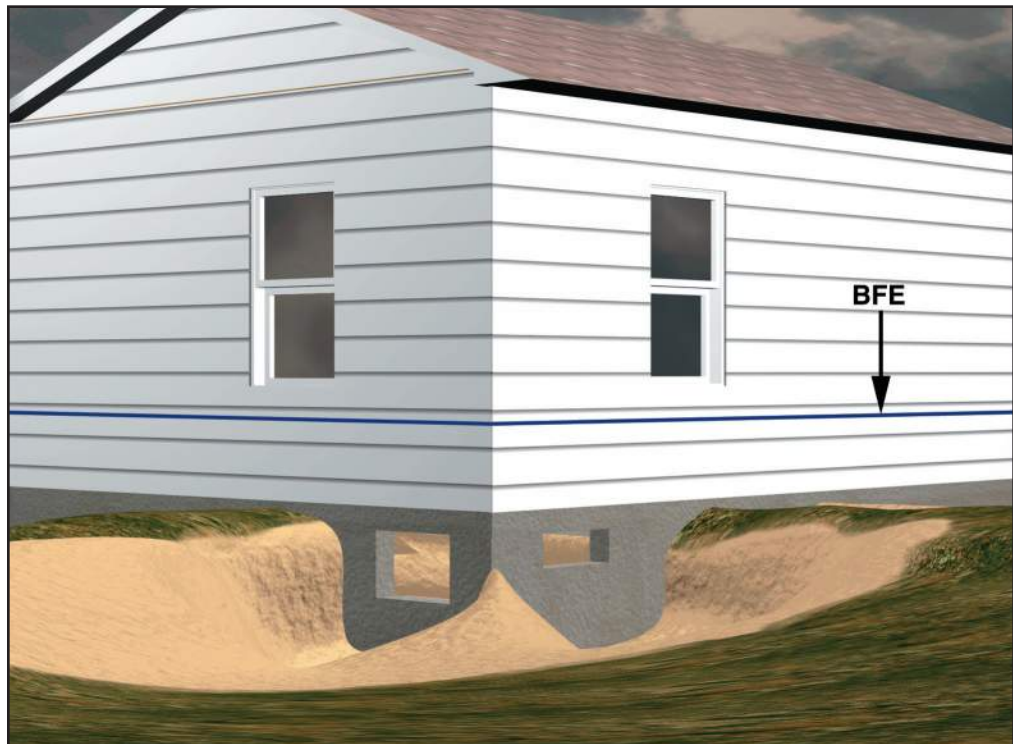
Figure 17
Trenches and tunnels under the slab provide access for the jacks and I-beams that will lift the house.

First, trenches are dug to expose the foundation walls immediately below the slab. Holes are then cut in the foundation walls at intervals around the house, and tunnels are dug under the slab (Figure 17). Jacks are placed in the trenches and large I-beams are inserted through the tunnels and allowed to rest on the jacks. Smaller I-beams are then inserted through the tunnels at right angles to the larger beams and positioned on top of them. The smaller beams support the slab when the house is raised (Figure 18).

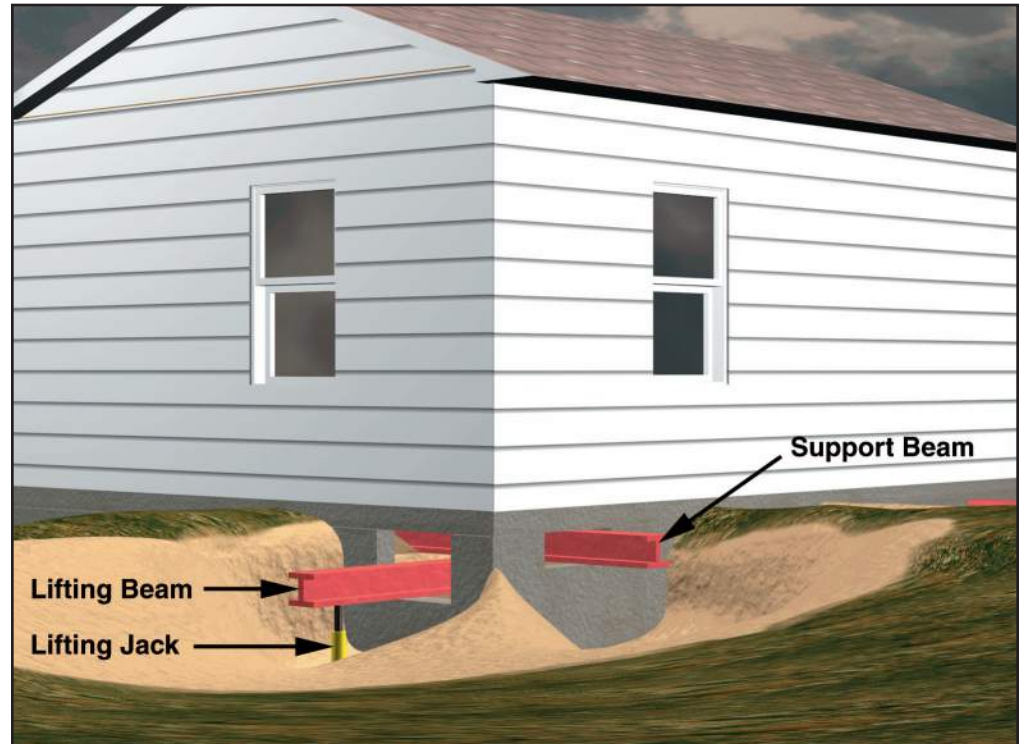
Figure 18
With I-beams and jacks in place, the house is ready to be lifted.

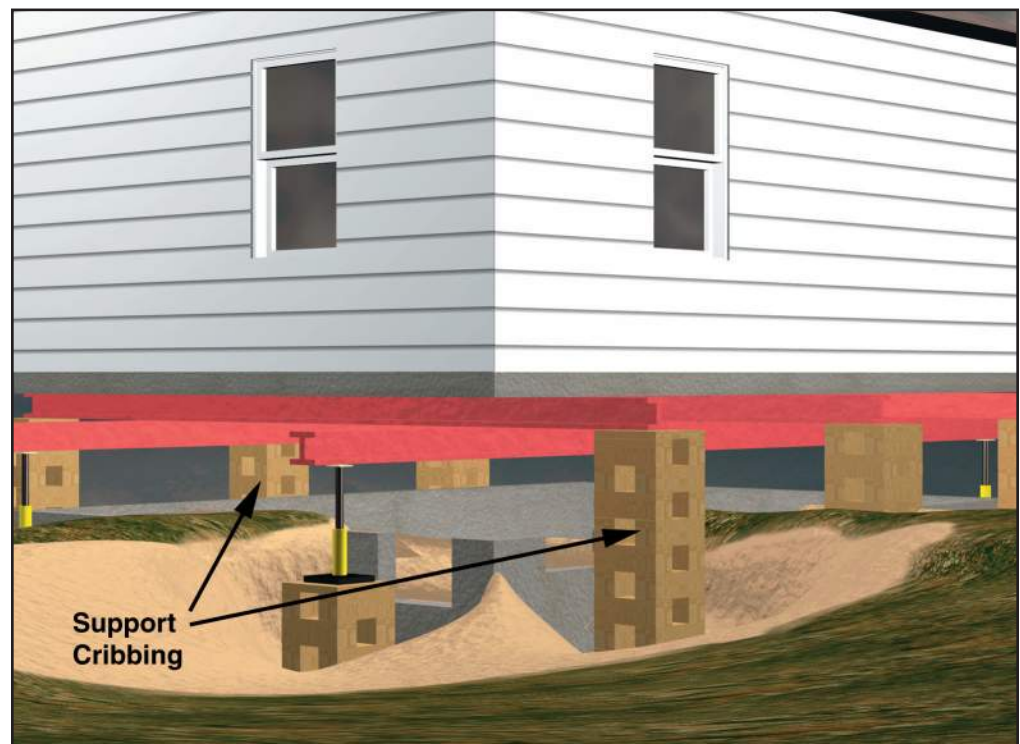
Figure 19
The house is temporarily supported on cribbing.

The house is then jacked up. When the jacks have extended as far as possible, the house must be supported temporarily while the jacks are raised. Both the house and the jacks are usually supported on “cribbing”—temporary piles of crisscrossed timbers (Figure 19). The jacks are then used to raise the house higher.

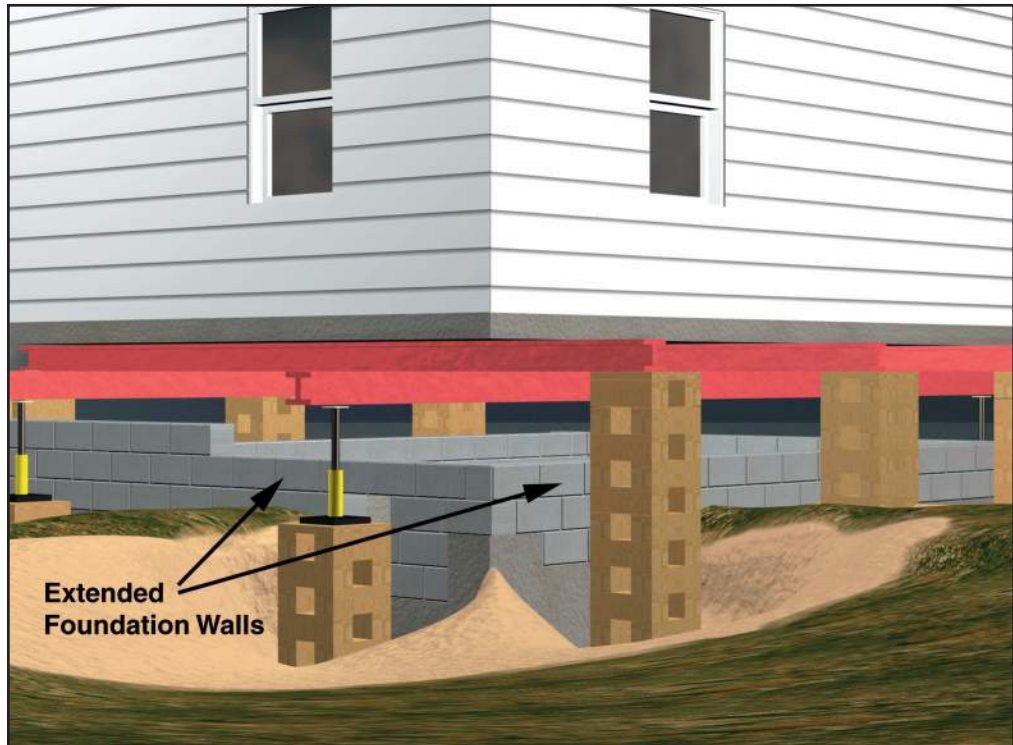
Figure 20
New, extended
foundation walls are
constructed with
concrete blocks.

This process is repeated until the house is raised to the desired height. The foundation walls are then extended upward with additional rows of concrete block (Figure 20). As in the previous techniques, openings are made in the walls within 1 foot of the ground so that flood waters will be able to flow into and out of the area below the elevated floor. The jacks and beams are removed, and the openings left around the beams are filled with blocks (Figure 21).

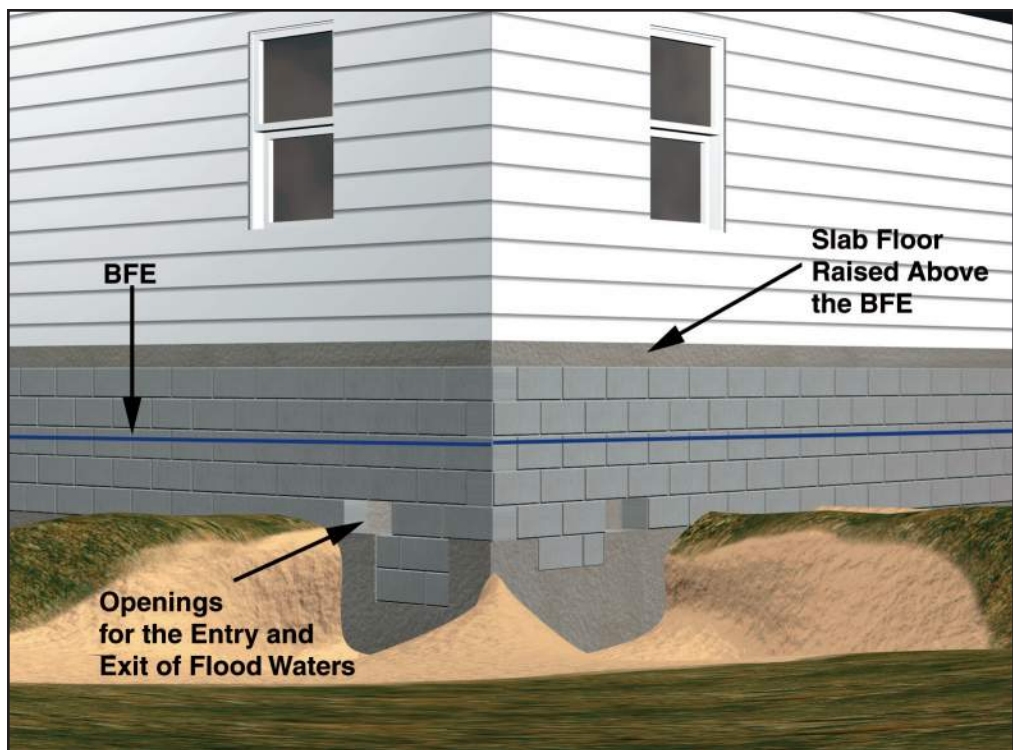
Figure 21
Elevated house and
slab on new, extended
foundation walls.

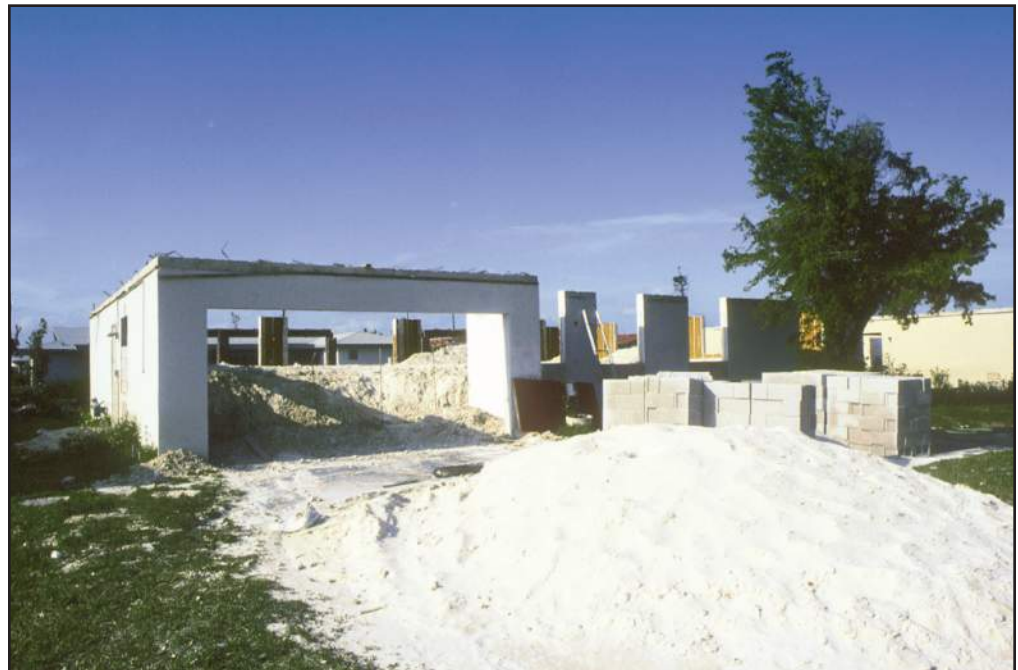
Figure 22

The front of the house at the beginning of the project. The interior walls and contents, which were destroyed or severely damaged by flood waters, wind, and rain, have been removed. Sand has been placed on top of the old slab to provide the base for the elevated lowest floor. The concrete blocks that will be used to extend the walls can be seen stored in the foreground.

The first case study house (Figures 22–32) has masonry walls and a slab-on-grade foundation. The roof of this house was severely damaged by high winds during Hurricane Andrew, and the interior walls suffered extensive damage from flood waters and rain. The owner decided to raise the lowest floor above the BFE by extending the walls upward, placing sand fill on top of the original slab floor, and pouring a new, elevated concrete slab on top.

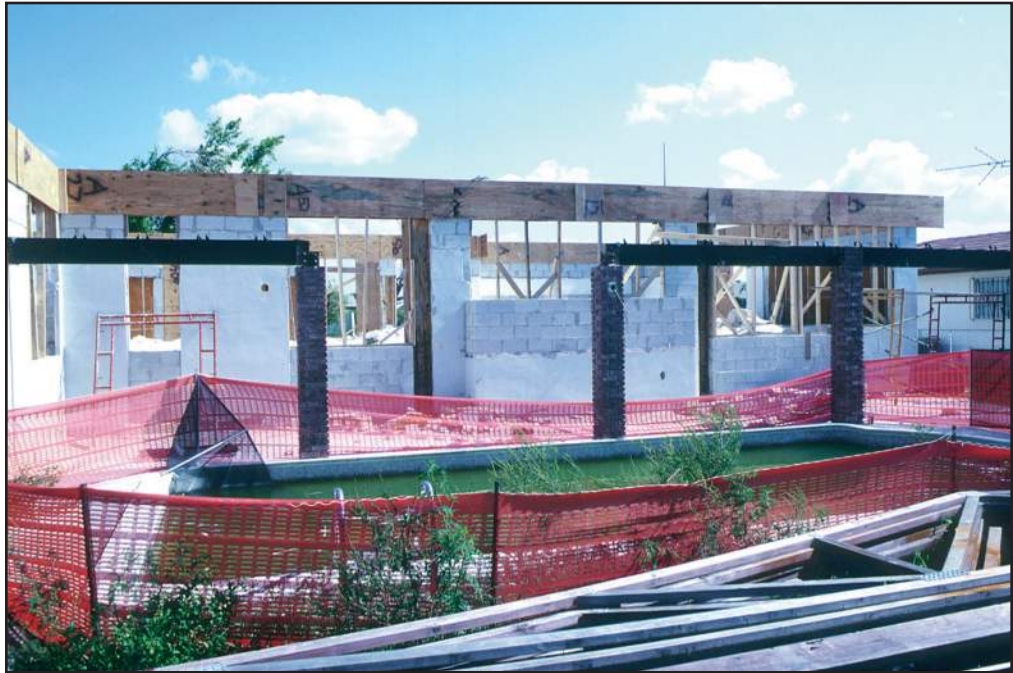
Figure 23
View from the back of the house. The walls have been extended upward with concrete blocks. The plywood visible at the tops of the walls is used to form cast-in-place concrete bond beams that will strengthen the extended walls. The roof trusses shown in the foreground were salvaged for reinstallation. The owner of this house decided to replace the original roof sheathing and shingles with new materials.

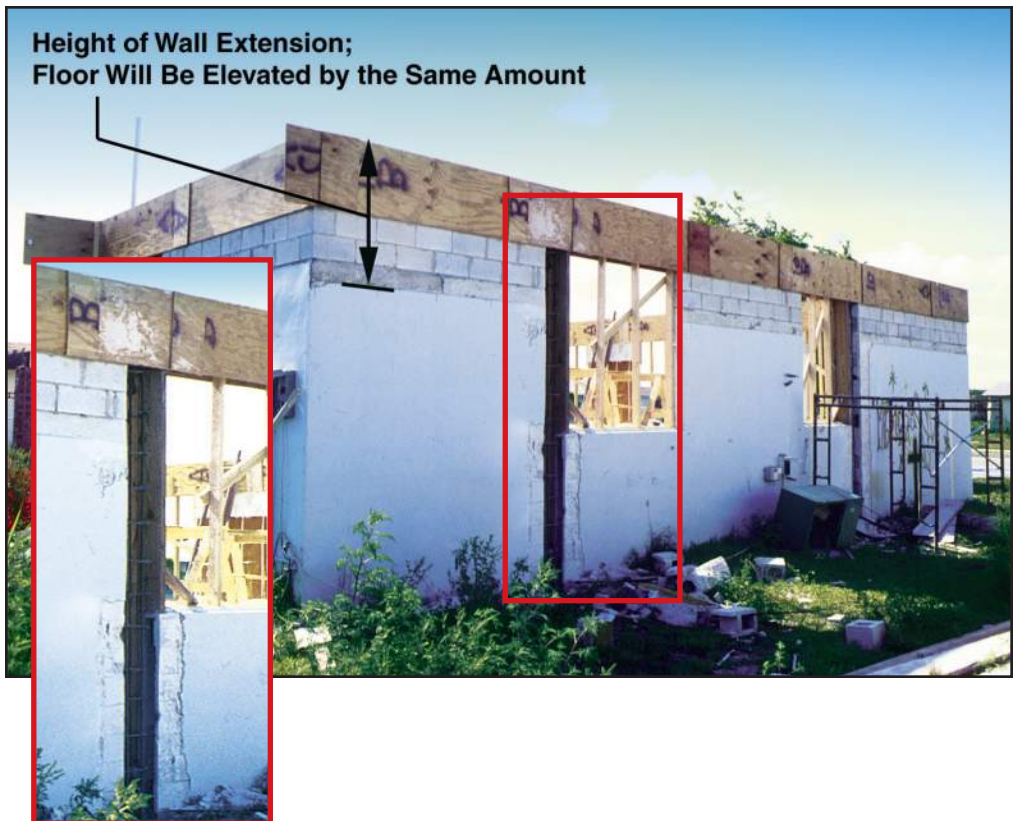
Figure 24
Another view of the extended walls. The vertical cuts in the walls next to the windows are for concrete tiedown columns that will be cast in place to further strengthen the extended walls against wind loads. The owner of this house was able to meet the elevation requirement by raising the floor only a few feet, as indicated by the amount that the walls have been extended.

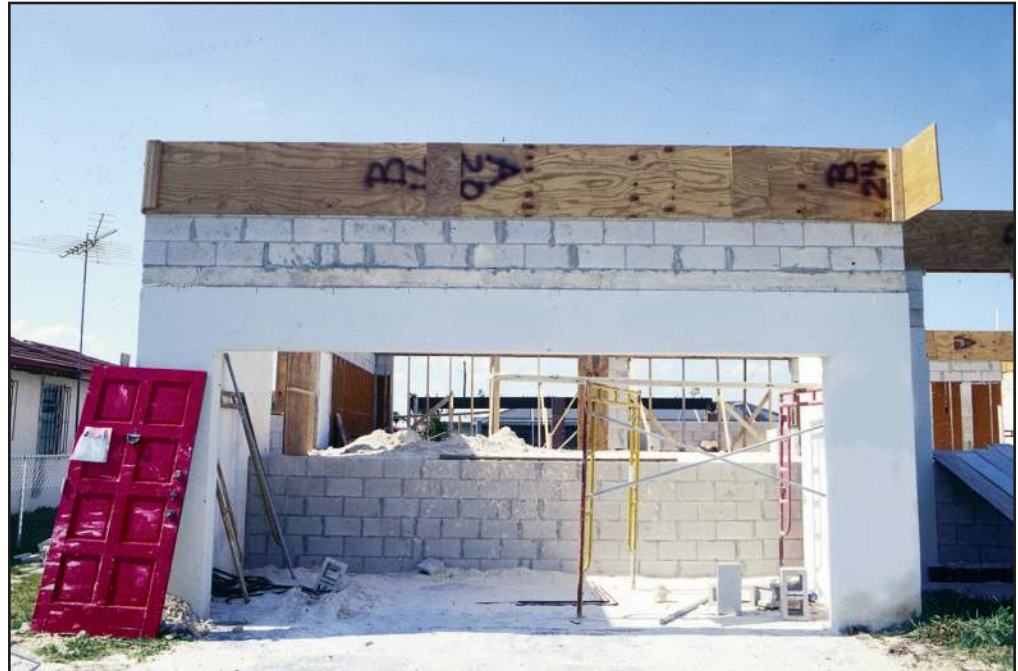
Figure 25

This view through the garage door reveals the different levels of the elevated slab floor, in the background, and the unelevated garage floor.

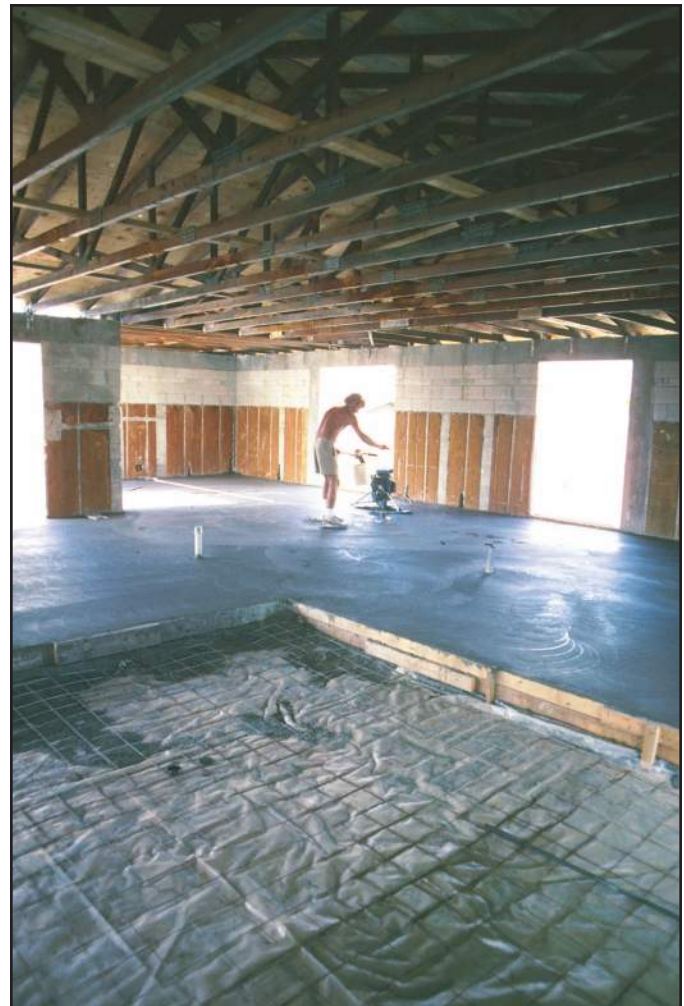
**Figure 26**

The roof has been rebuilt with the salvaged trusses, and most of the new concrete slab has been poured on top of the sand fill. The open area in the foreground, where plastic sheeting and wire reinforcement can be seen on top of the sand fill, is where the remaining part of the slab will be poured.

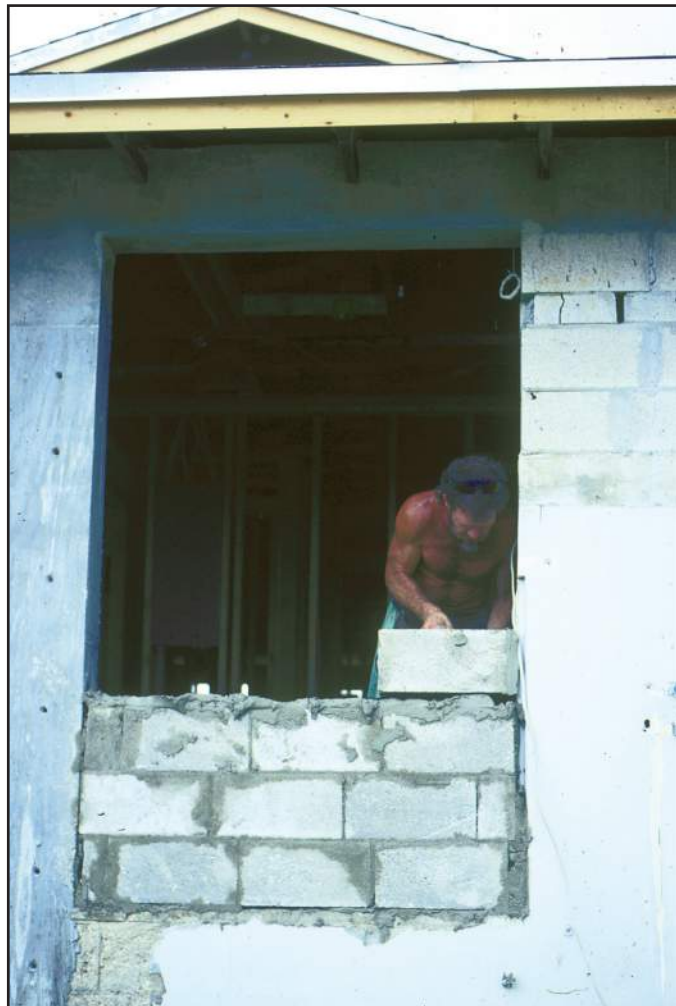
Figure 28
The bottoms of the
original window
openings are raised
with concrete blocks.

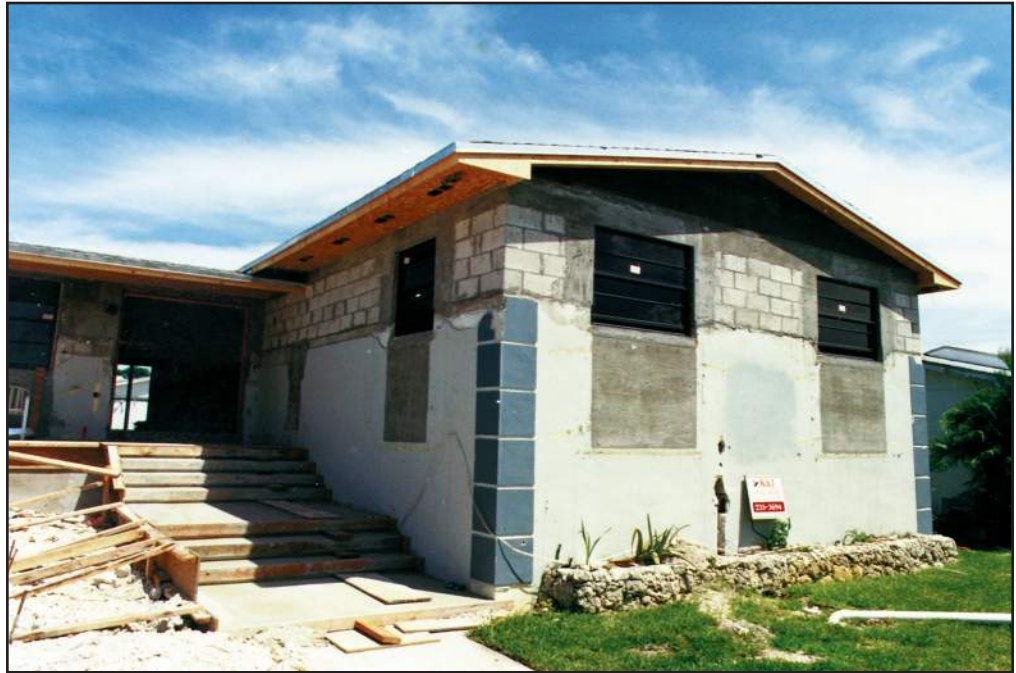
**Figure 37**

The project nears completion. In this house, as in Case Study 1, the level of the garage floor remains unchanged.

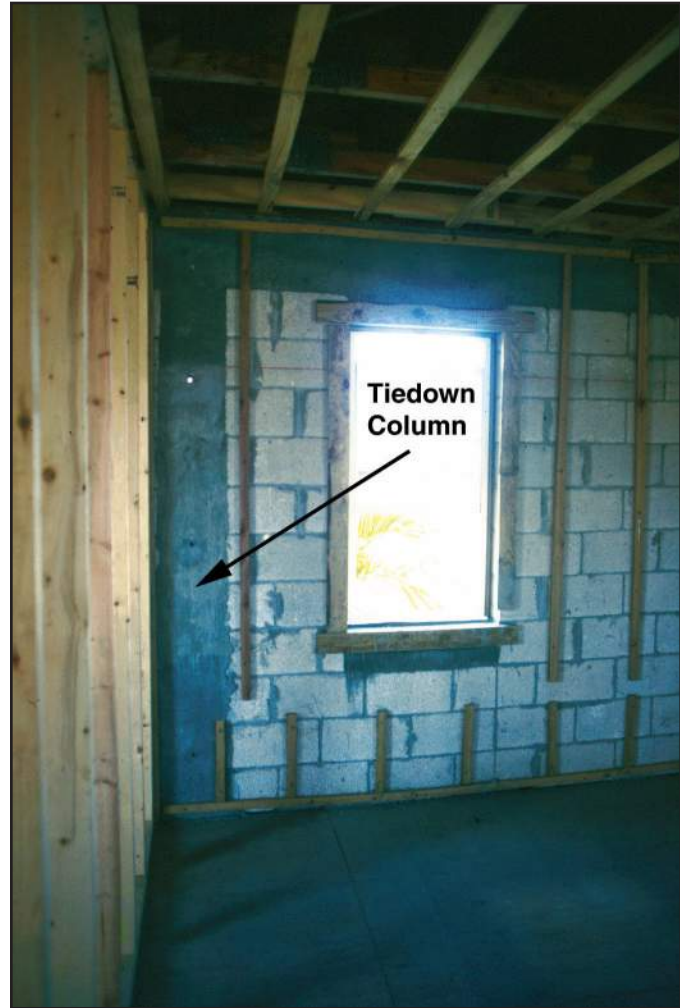
Figure 47
The tiedown columns extend down from the new second-story walls and into the original first-floor walls. The columns tie the first and second stories together and provide a continuous load path that helps the house resist the forces of high winds.
