Above the Flood: Elevating Your Floodprone House

FEMA 347/ May 2000

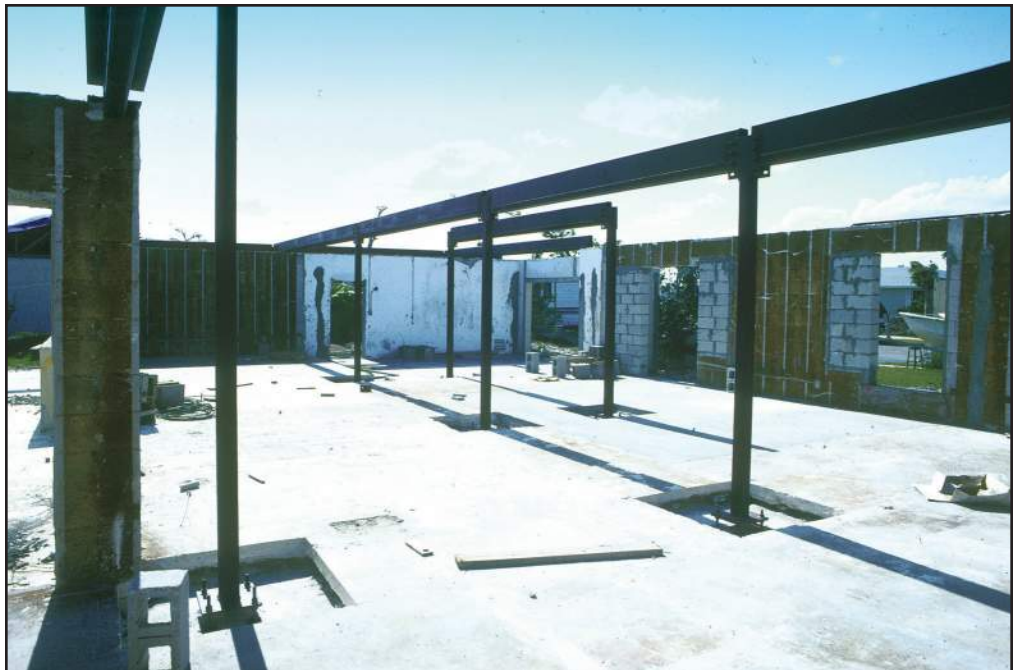
Figure 52

The existing first-story walls have been strengthened by the addition of concrete block. Metal columns and beams have been added to help support the new second story.

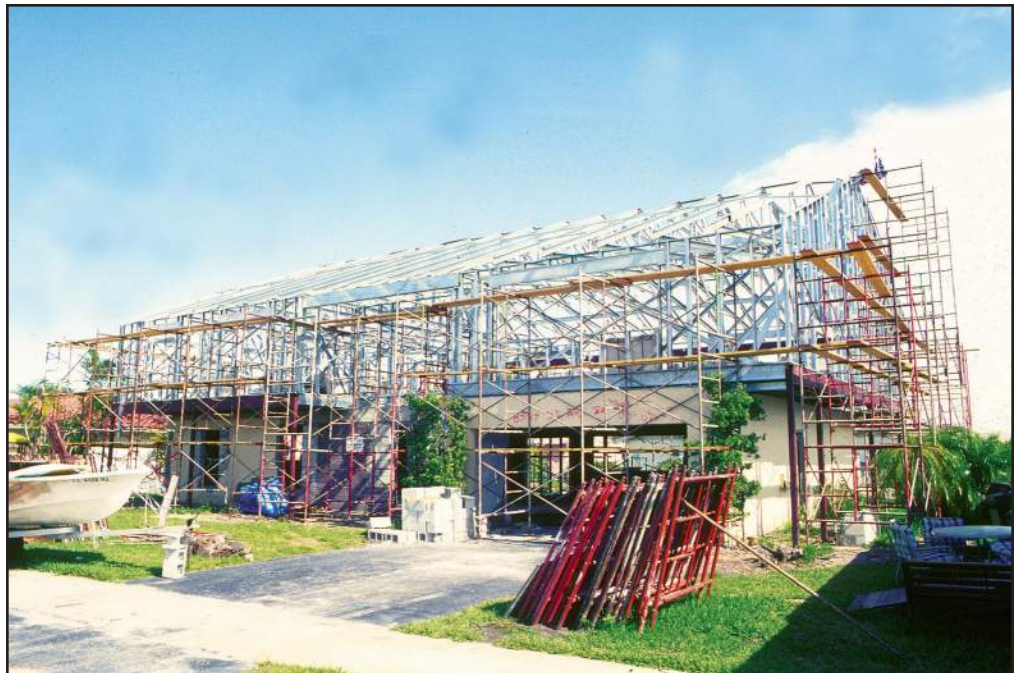
Figure 54
Metal framing is used for the new second story, including the walls and roof support system.

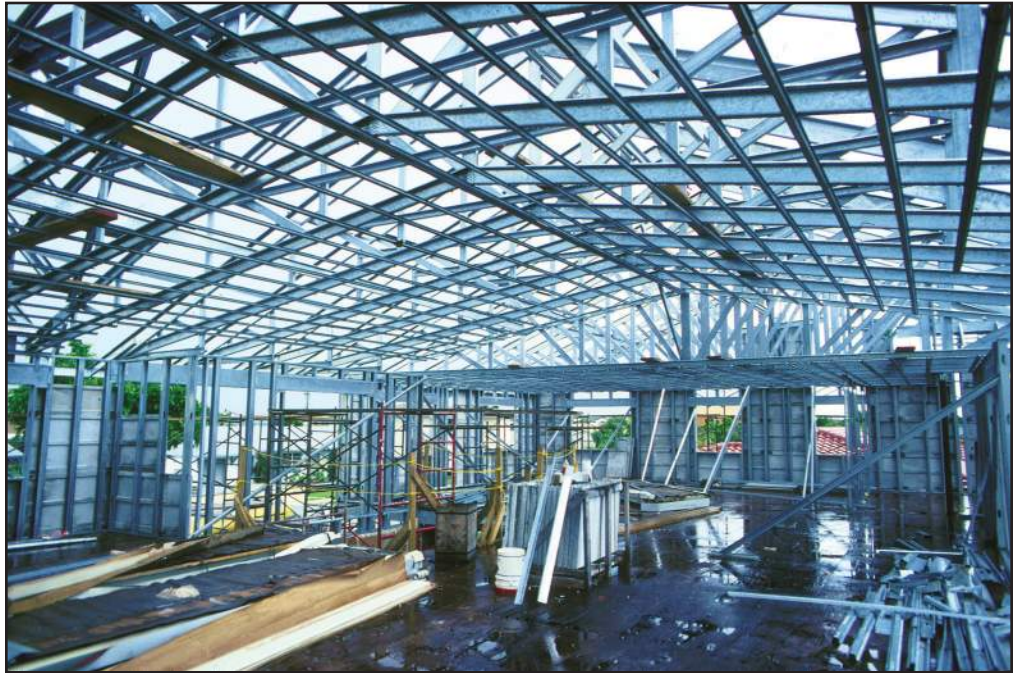
Figure 55
Metal framing also supports the floor of the new second story.

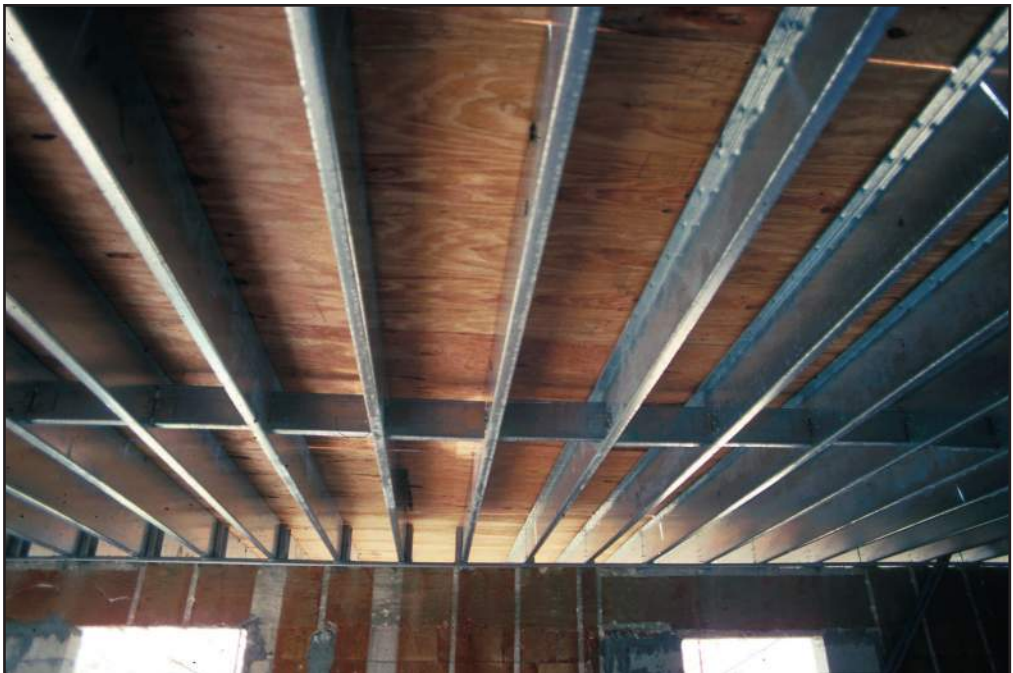
Figure 56

One advantage of metal framing is its relatively light weight. An additional advantage is that the screws used to attach metal-frame components provide strong connections.

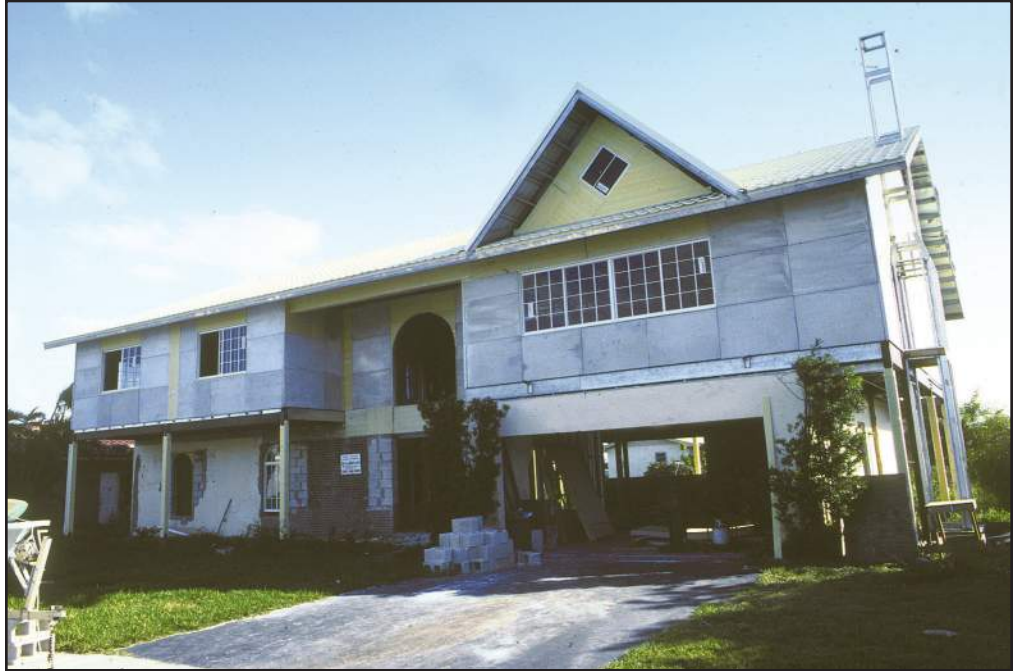
Figure 59

The exterior
walls consist of
prefabricated
concrete panels.
Innovative techniques
such as those
employed in this
project are helping
homeowners who
need practical and
economical methods
of repairing and
protecting their
houses.

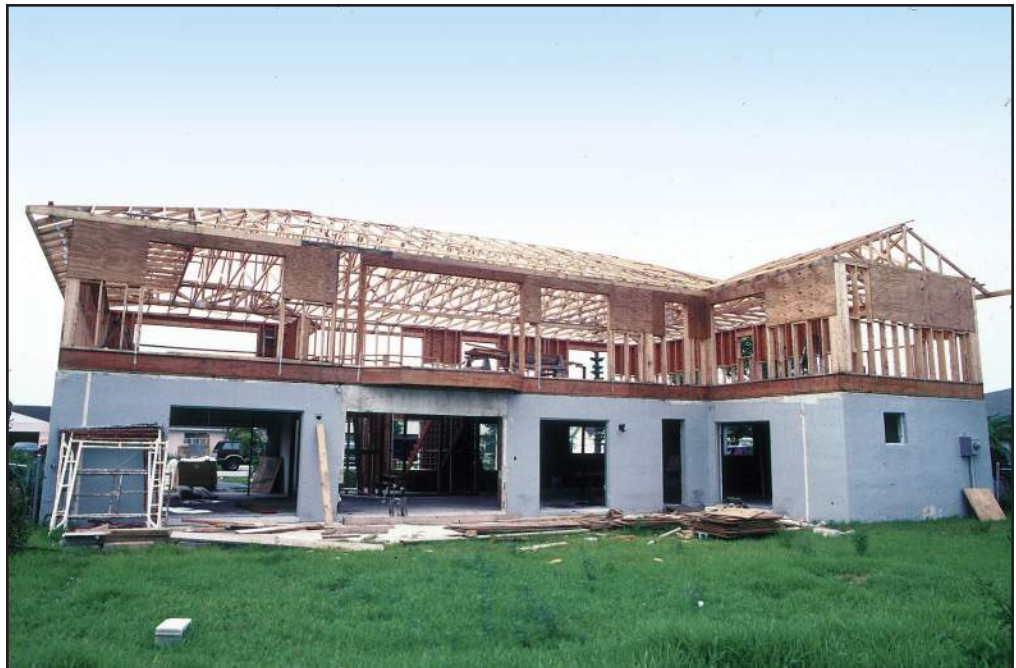
Figure 62
After the wood framing was completed, the roof and exterior wall sheathing were added.

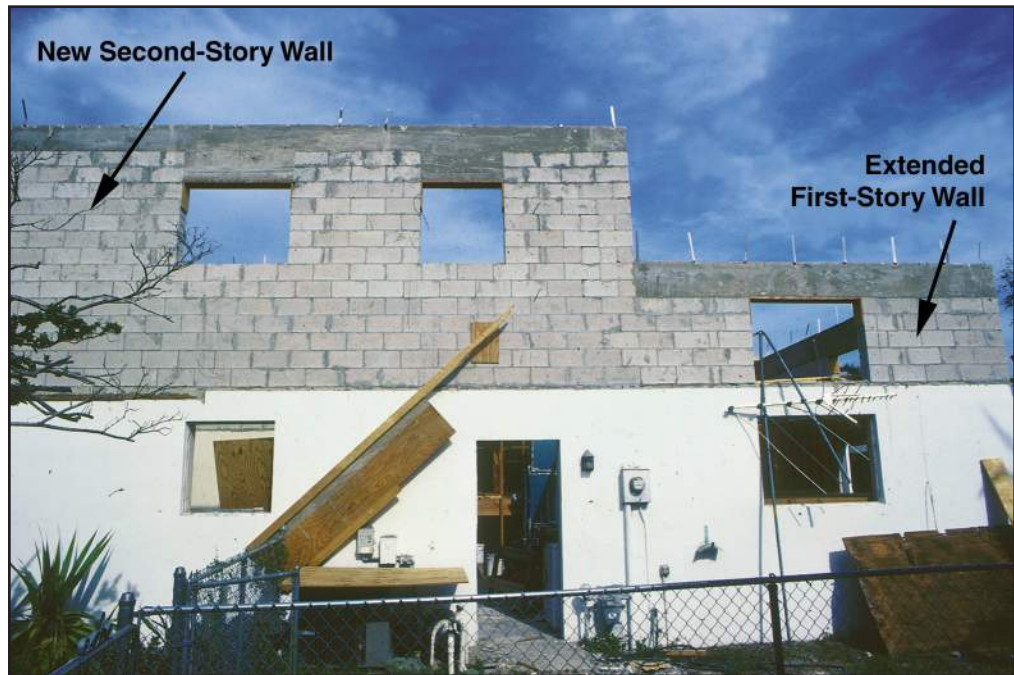
Figure 65

After the house was gutted, the walls were extended upward with reinforced concrete block. In this view from behind the house, the rear wall of the new second story can be seen on the left and the extended first-story wall on the right. Note the new raised window opening in the extended wall, just above the original opening.

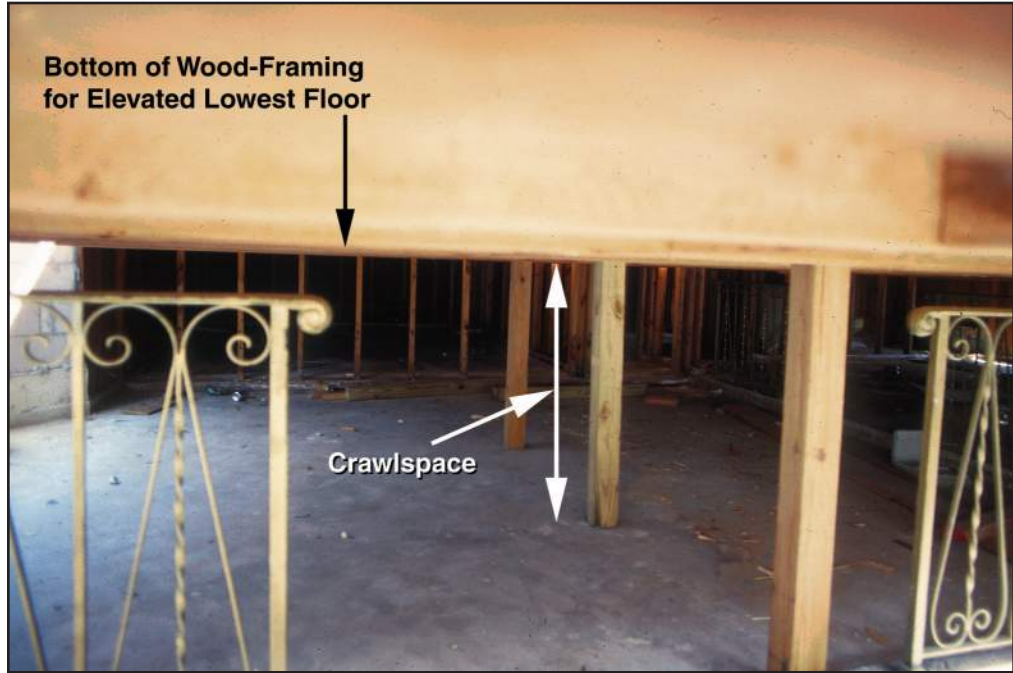
Figure 68

Rather than install a new concrete slab on compacted fill, the owner of this house chose to build a new wood-frame floor above the old concrete slab. This method creates a crawlspace below the new floor.

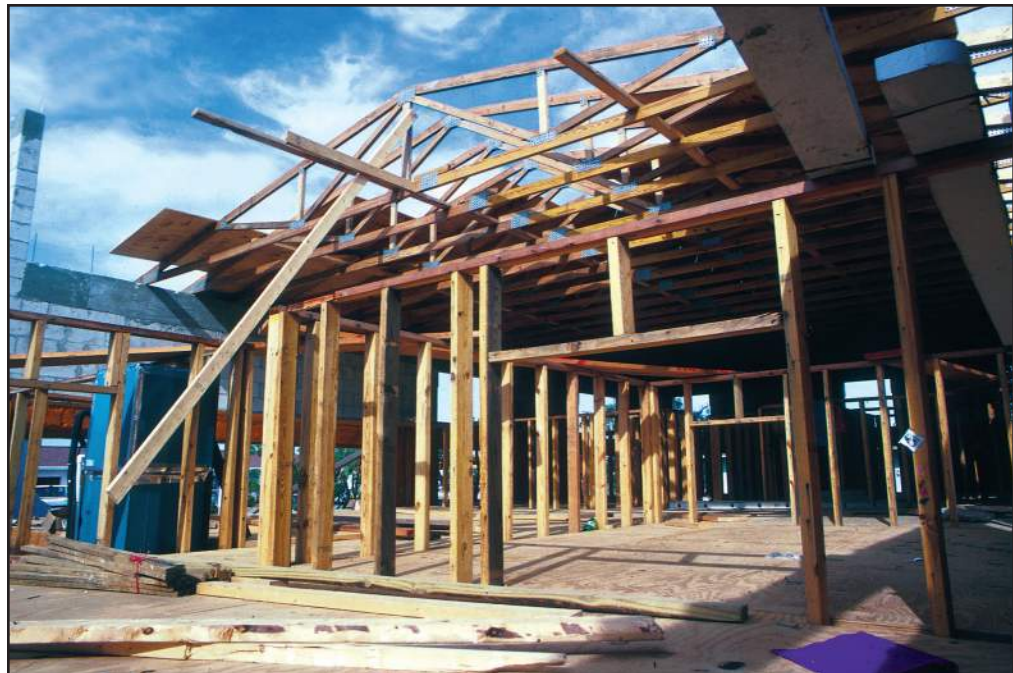
Wood framing is used for the new second story.

Figure 69 Wood framing is used for the new second story. 4-26

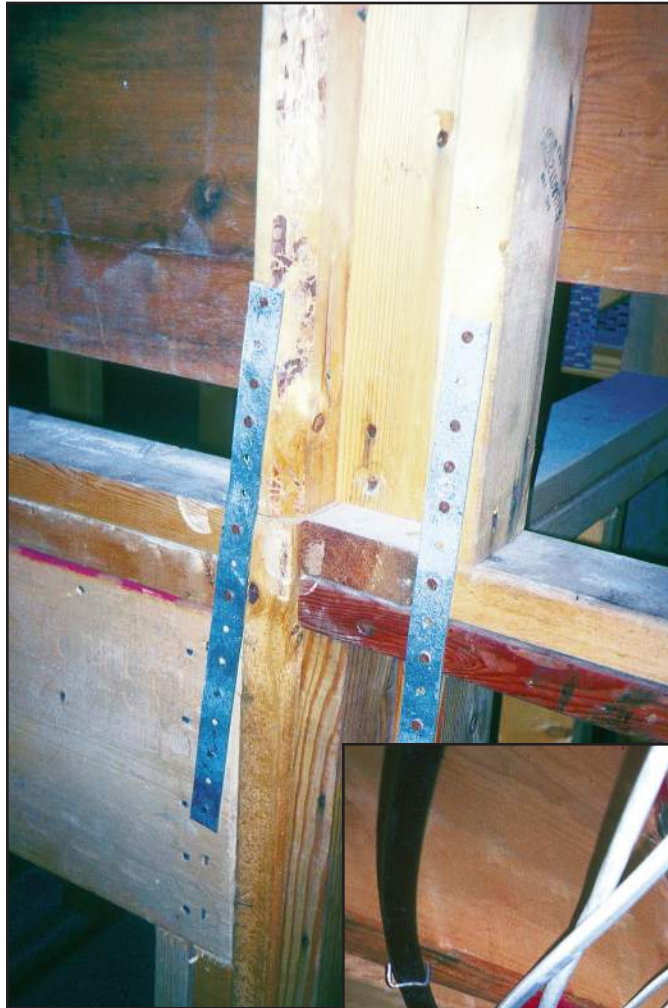
Metal hurricane straps are used to tie the structural members together and create a continuous load path from the roof to the foundation.

Figure 70	Metal hurricane straps are used to tie the structural members together and create a continuous load path from the roof to the foundation.	4-27
Figure 71	All plumbing and electrical renovation work must be performed according to state and local code requirements.	4-27
Figure 72	The completed house is compliant with local floodplain management requirements, is more resistant to flood damage, and provides additional living area above the flood level.	4-28
Figure 73	Like the houses shown previously, this one-story house, with its concrete block walls, concrete slab foundation, and attached garage, is typical of the houses in the area affected by Hurricane Andrew.	4-28
Figure 74	In this variation of Technique 3, steel beams are inserted through the walls of the house rather than under the slab.	4-29
Figure 75	Electrical lines and other utilities were disconnected early in the project.	4-29

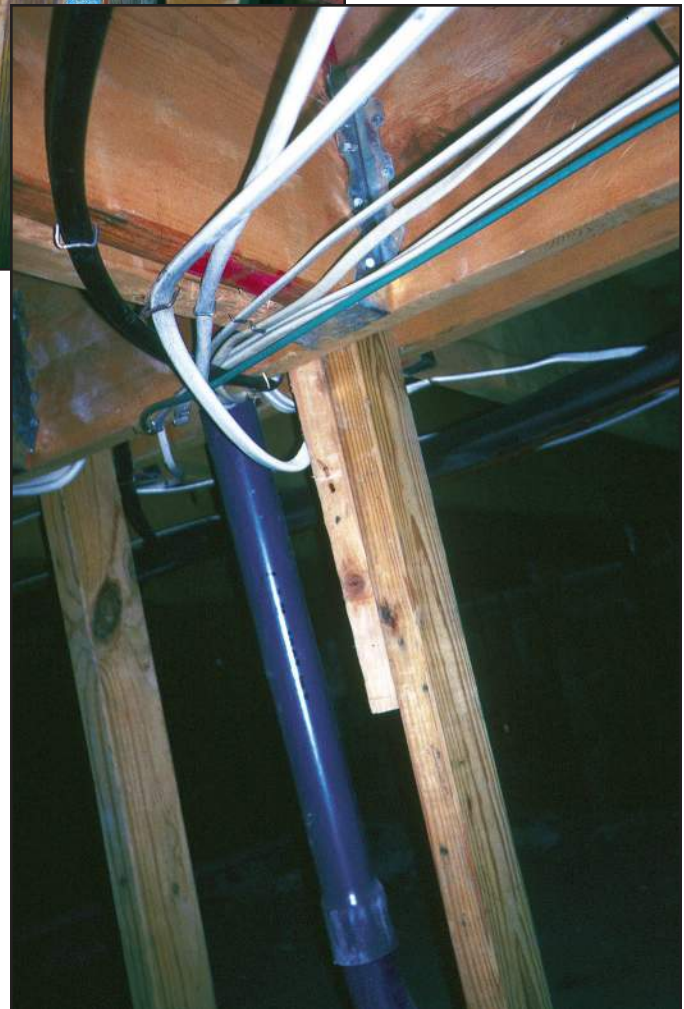
**Figure 71**

All plumbing and electrical renovation work must be performed according to state and local code requirements.

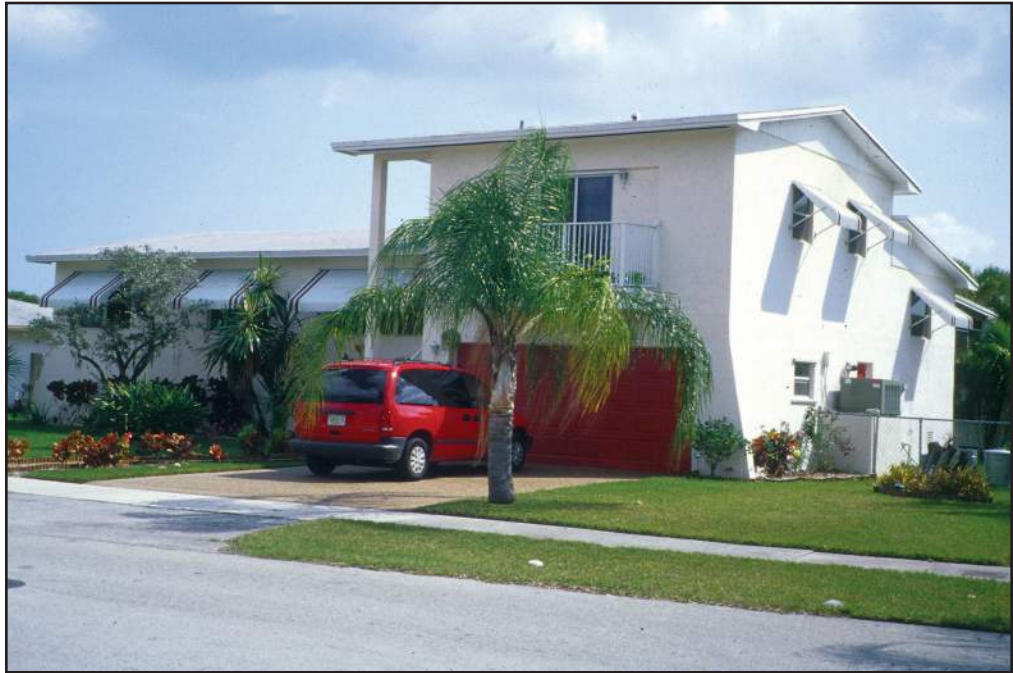
Figure 72
The completed house is compliant with local floodplain management requirements, is more resistant to flood damage, and provides additional living area above the flood level.

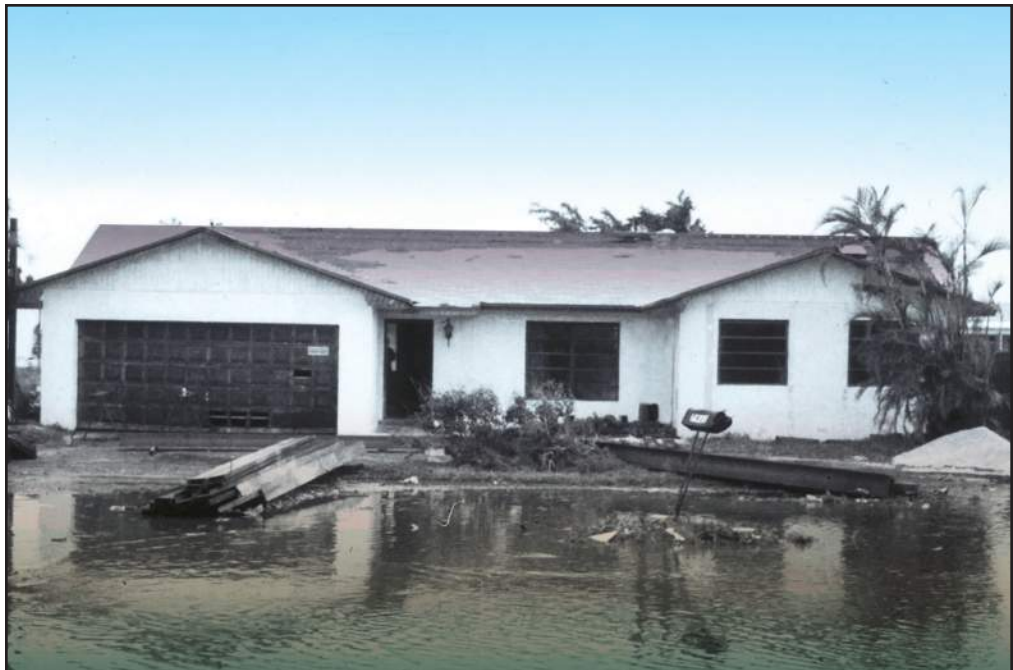
Figure 73
Like the houses shown previously, this one-story house, with its concrete block walls, concrete slab foundation, and attached garage, is typical of the houses in the area affected by Hurricane Andrew.

Unlike Techniques 1 and 2, which build up from the existing foundation and walls, Technique 3 lifts the entire house with hydraulic jacks and builds a new foundation below it (Figures 73–85).

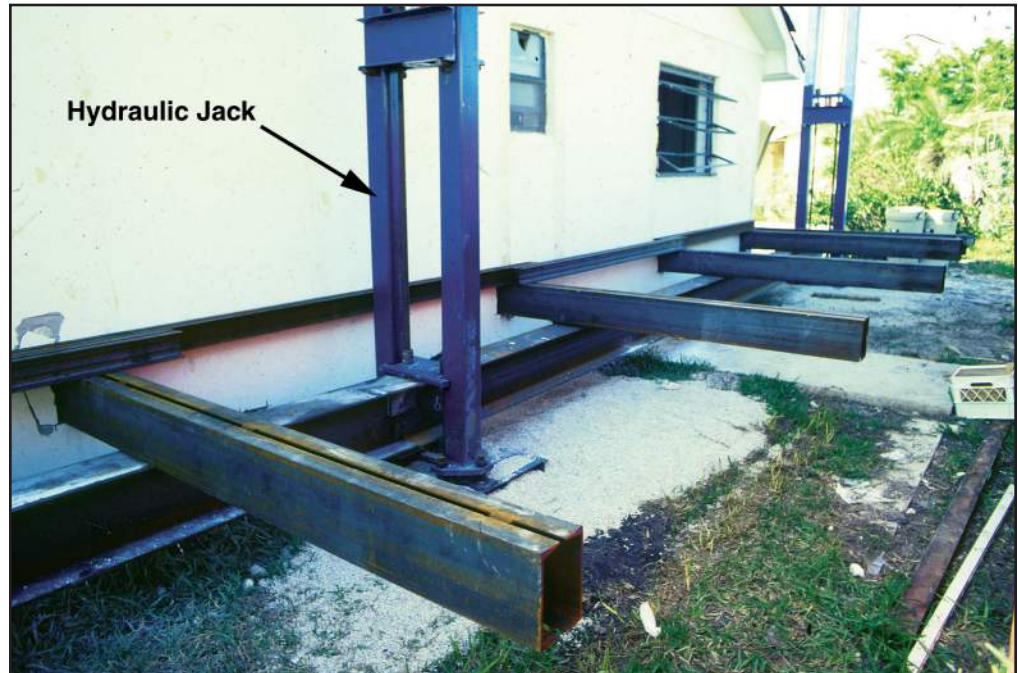
Figure 74

In this variation of Technique 3, steel beams are inserted through the walls of the house rather than under the slab. The beams span the length and width of the house and cross one another inside to create a grid. Outside the house, the beams rest on larger beams that will be raised with hydraulic jacks.

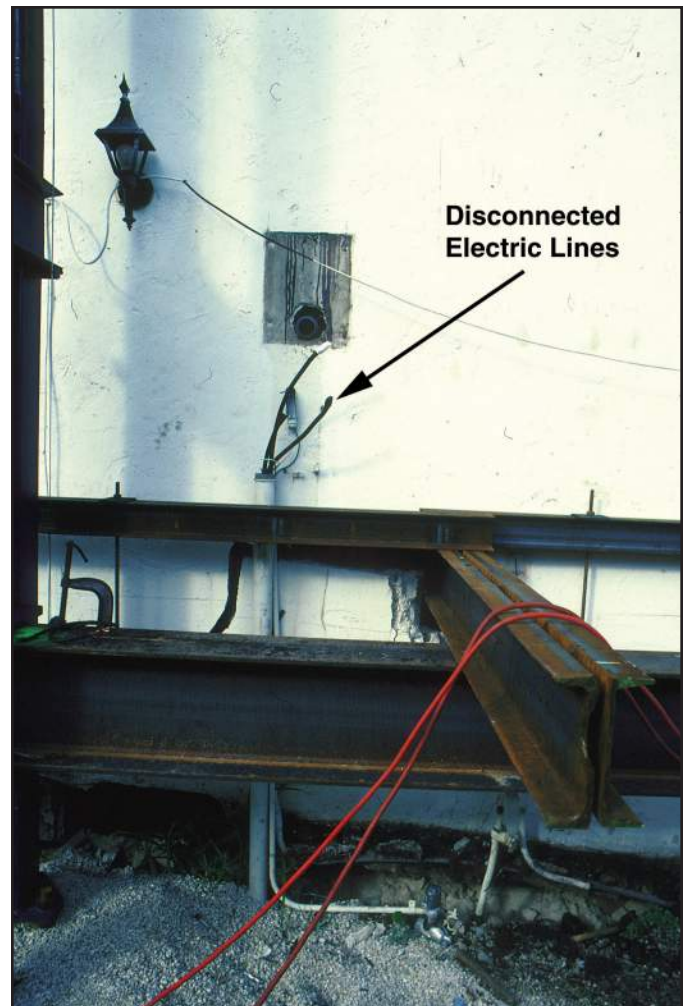
**Figure 75**

Electrical lines and other utilities were disconnected early in the project.

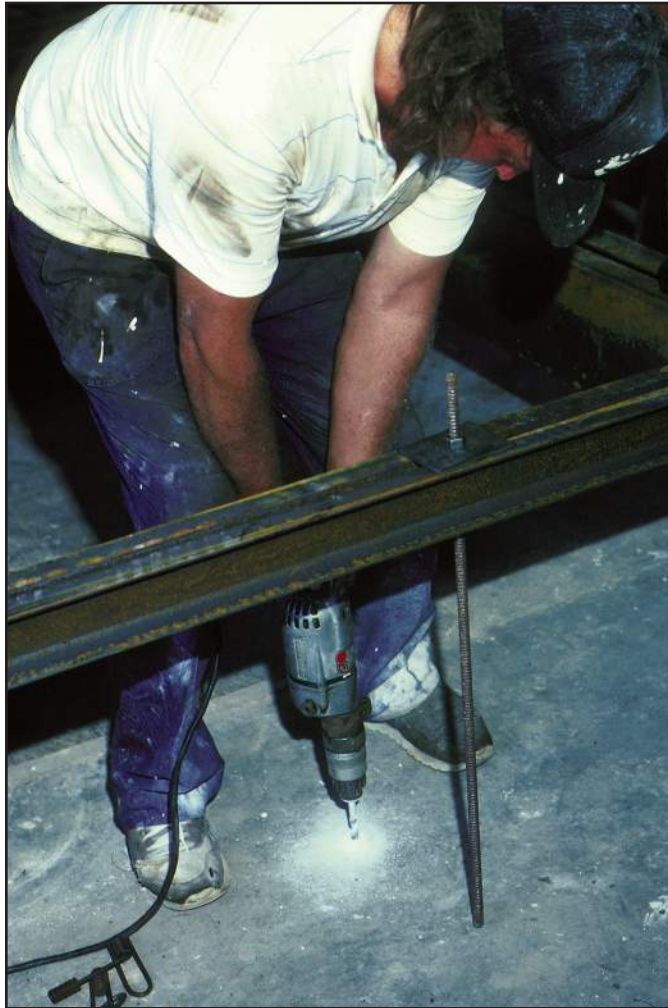
Figure 76
Inside the house,
workers drill holes in
the concrete slab ...

Figure 76	Inside the house, workers drill holes in the concrete slab ...	4-30
Figure 77	... install anchors ...	4-30
Figure 78	... and use hangers to attach the anchors to the grid of steel beams.	4-31
Figure 79	The anchors and hangers connect the slab securely to the beams, enabling the beams to raise the slab along with the rest of the house.	4-31
Figure 80	Lifting the house, while simple in theory, is complicated by the need to ensure an equal amount of lift at each jack throughout the process.	4-32
Figure 81	The house and slab were raised one full story.	4-32
Figure 82	While the jacks and beams supported the house, new steel foundation members were installed below.	4-33

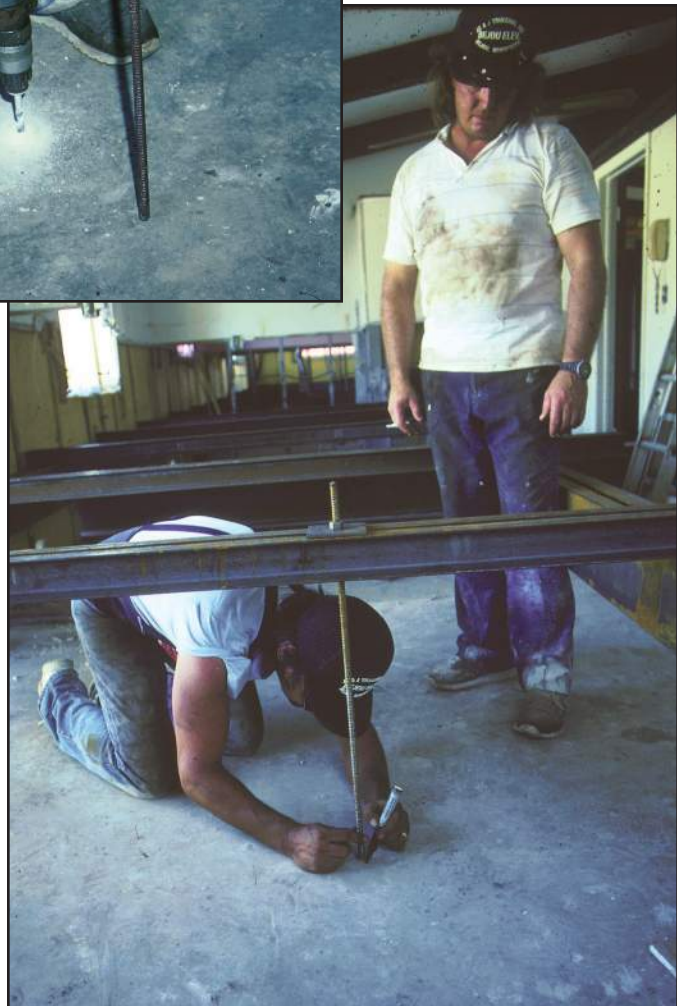
Figure 77
... install anchors ...

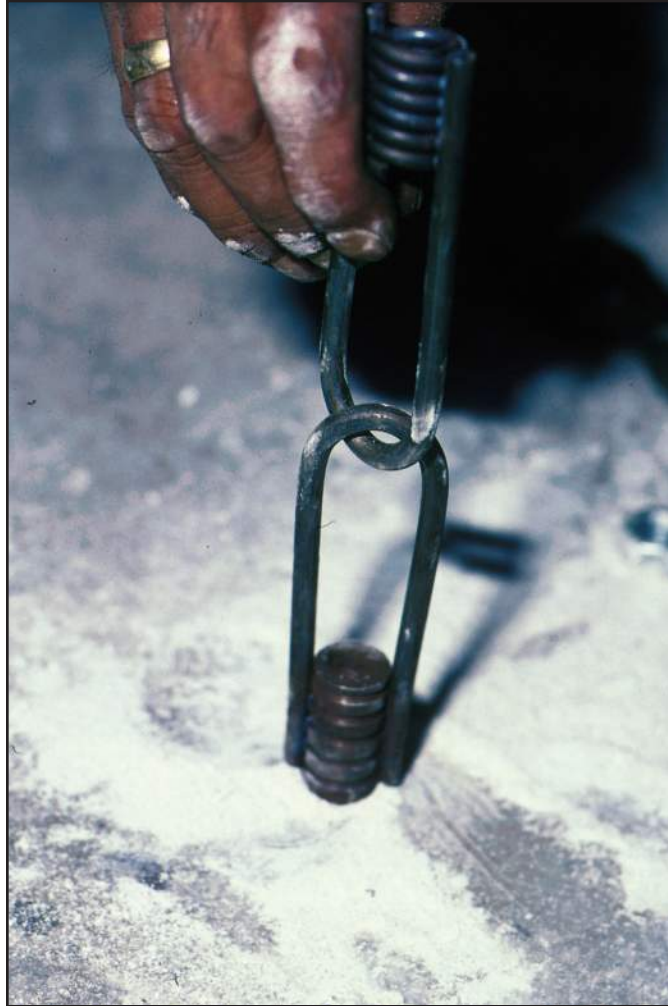
Figure 78
... and use hangers
to attach the anchors
to the grid of steel
beams.

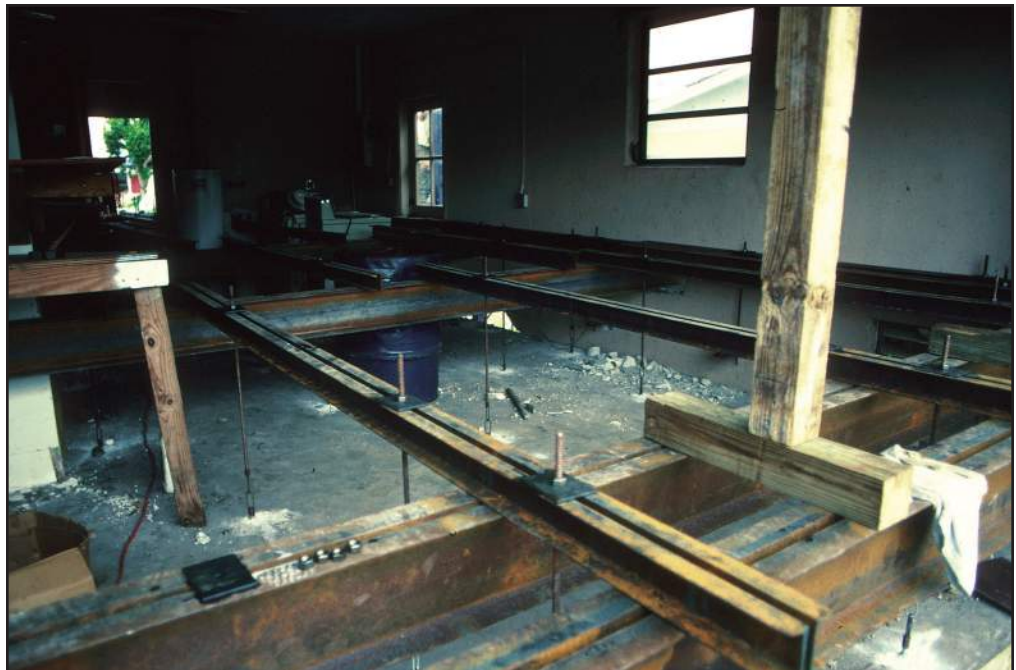
Figure 79
The anchors and
hangers connect the
slab securely to the
beams, enabling the
beams to raise the
slab along with the
rest of the house.

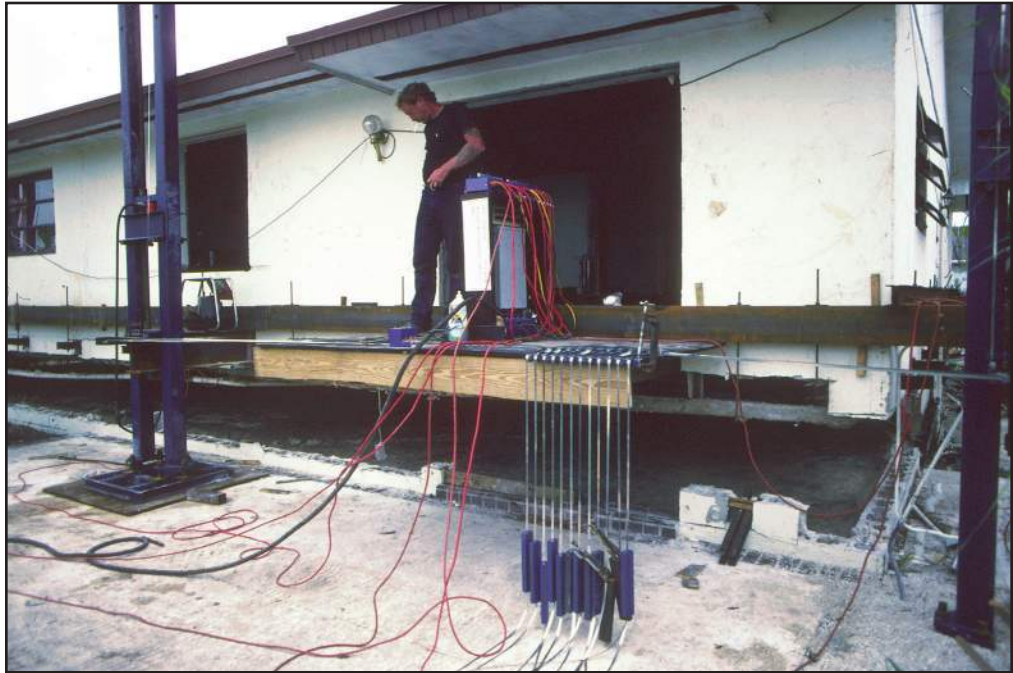
Figure 80

Lifting the house, while simple in theory, is complicated by the need to ensure an equal amount of lift at each jack throughout the process. Too much or too little lift at even one jack can cause the slab and walls to crack. The elevation contractor for this project used a sophisticated jacking system that provided the required level of control.

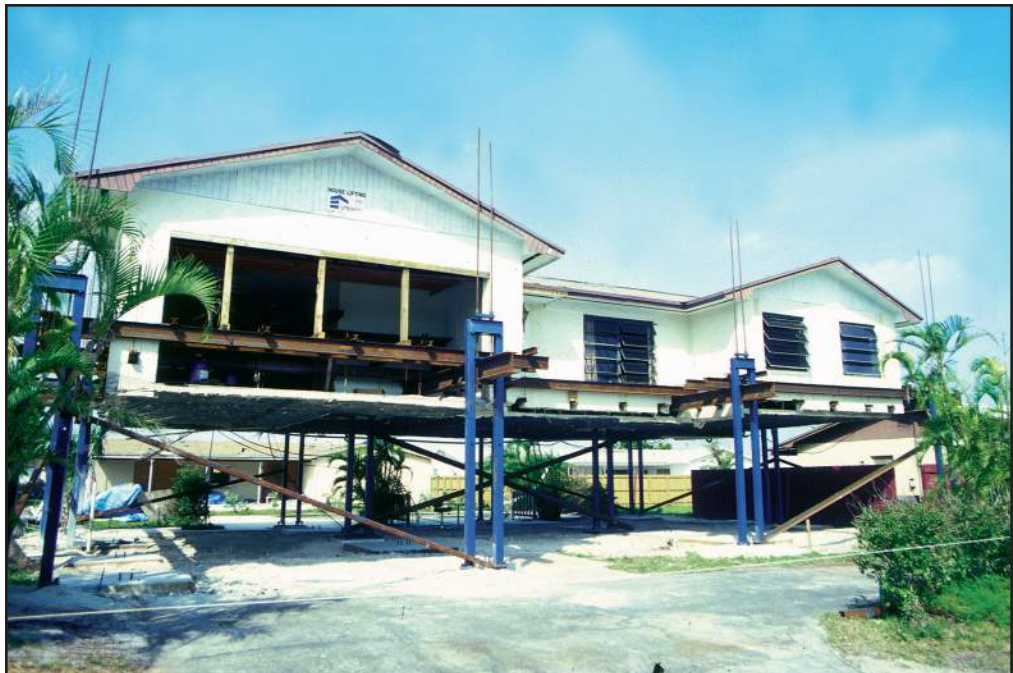
Figure 81

The house and slab were raised one full story.

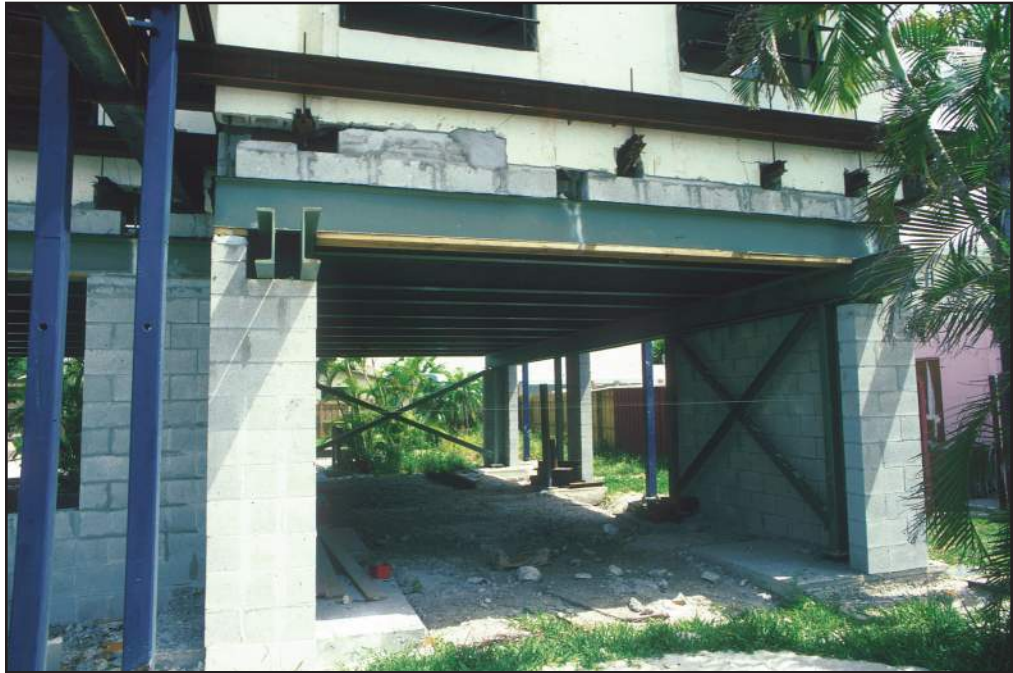
... and used to build the lower-level walls.

Figure 84 ... and used to build the lower-level walls. 4-34

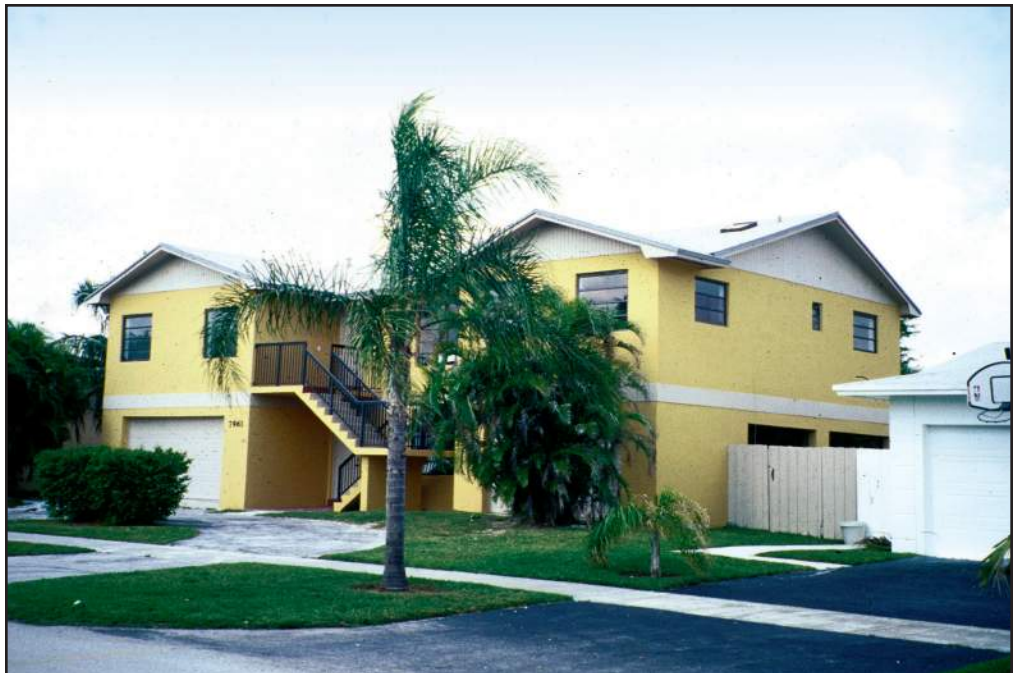
The completed house, with lower-level space for parking and storage and upper-level living space, looks as if it were originally designed and built as a two-story structure.

Figure 85 The completed house, with lower-level space for parking and storage and upper-level living space, looks as if it were originally designed and built as a two-story structure. 4-34
